# PHYSICAL AND MECHANICAL ACTIONS TO RESTORE SOIL STRUCTURE

David Polster, M.Sc. R.P.Bio.  
Polster Environmental Services Ltd.

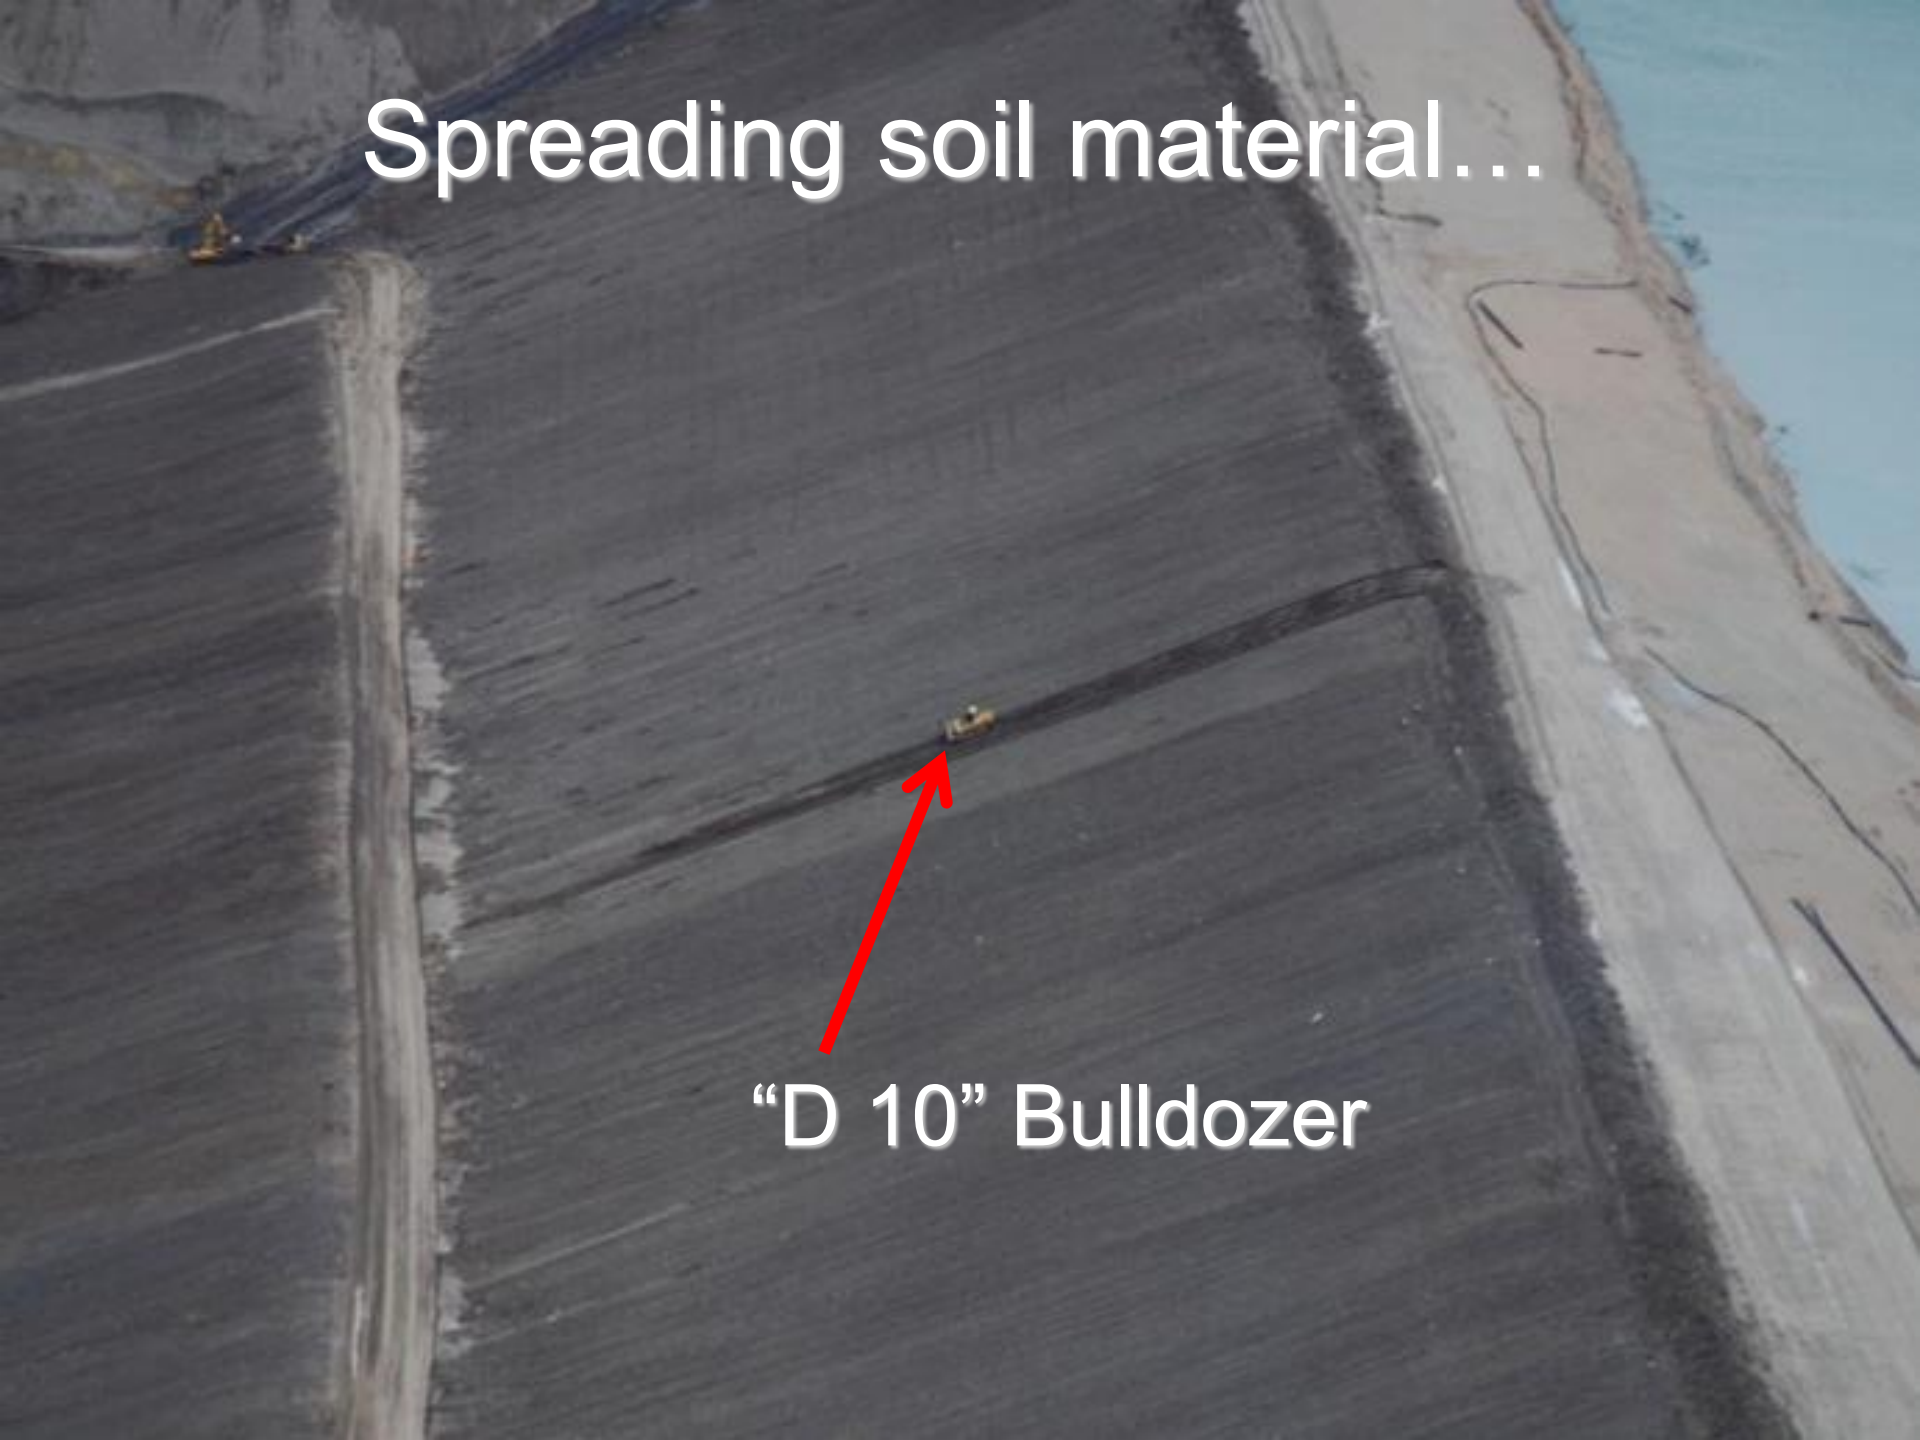
Erosion starting on smooth surface  
before spreading is even completed.

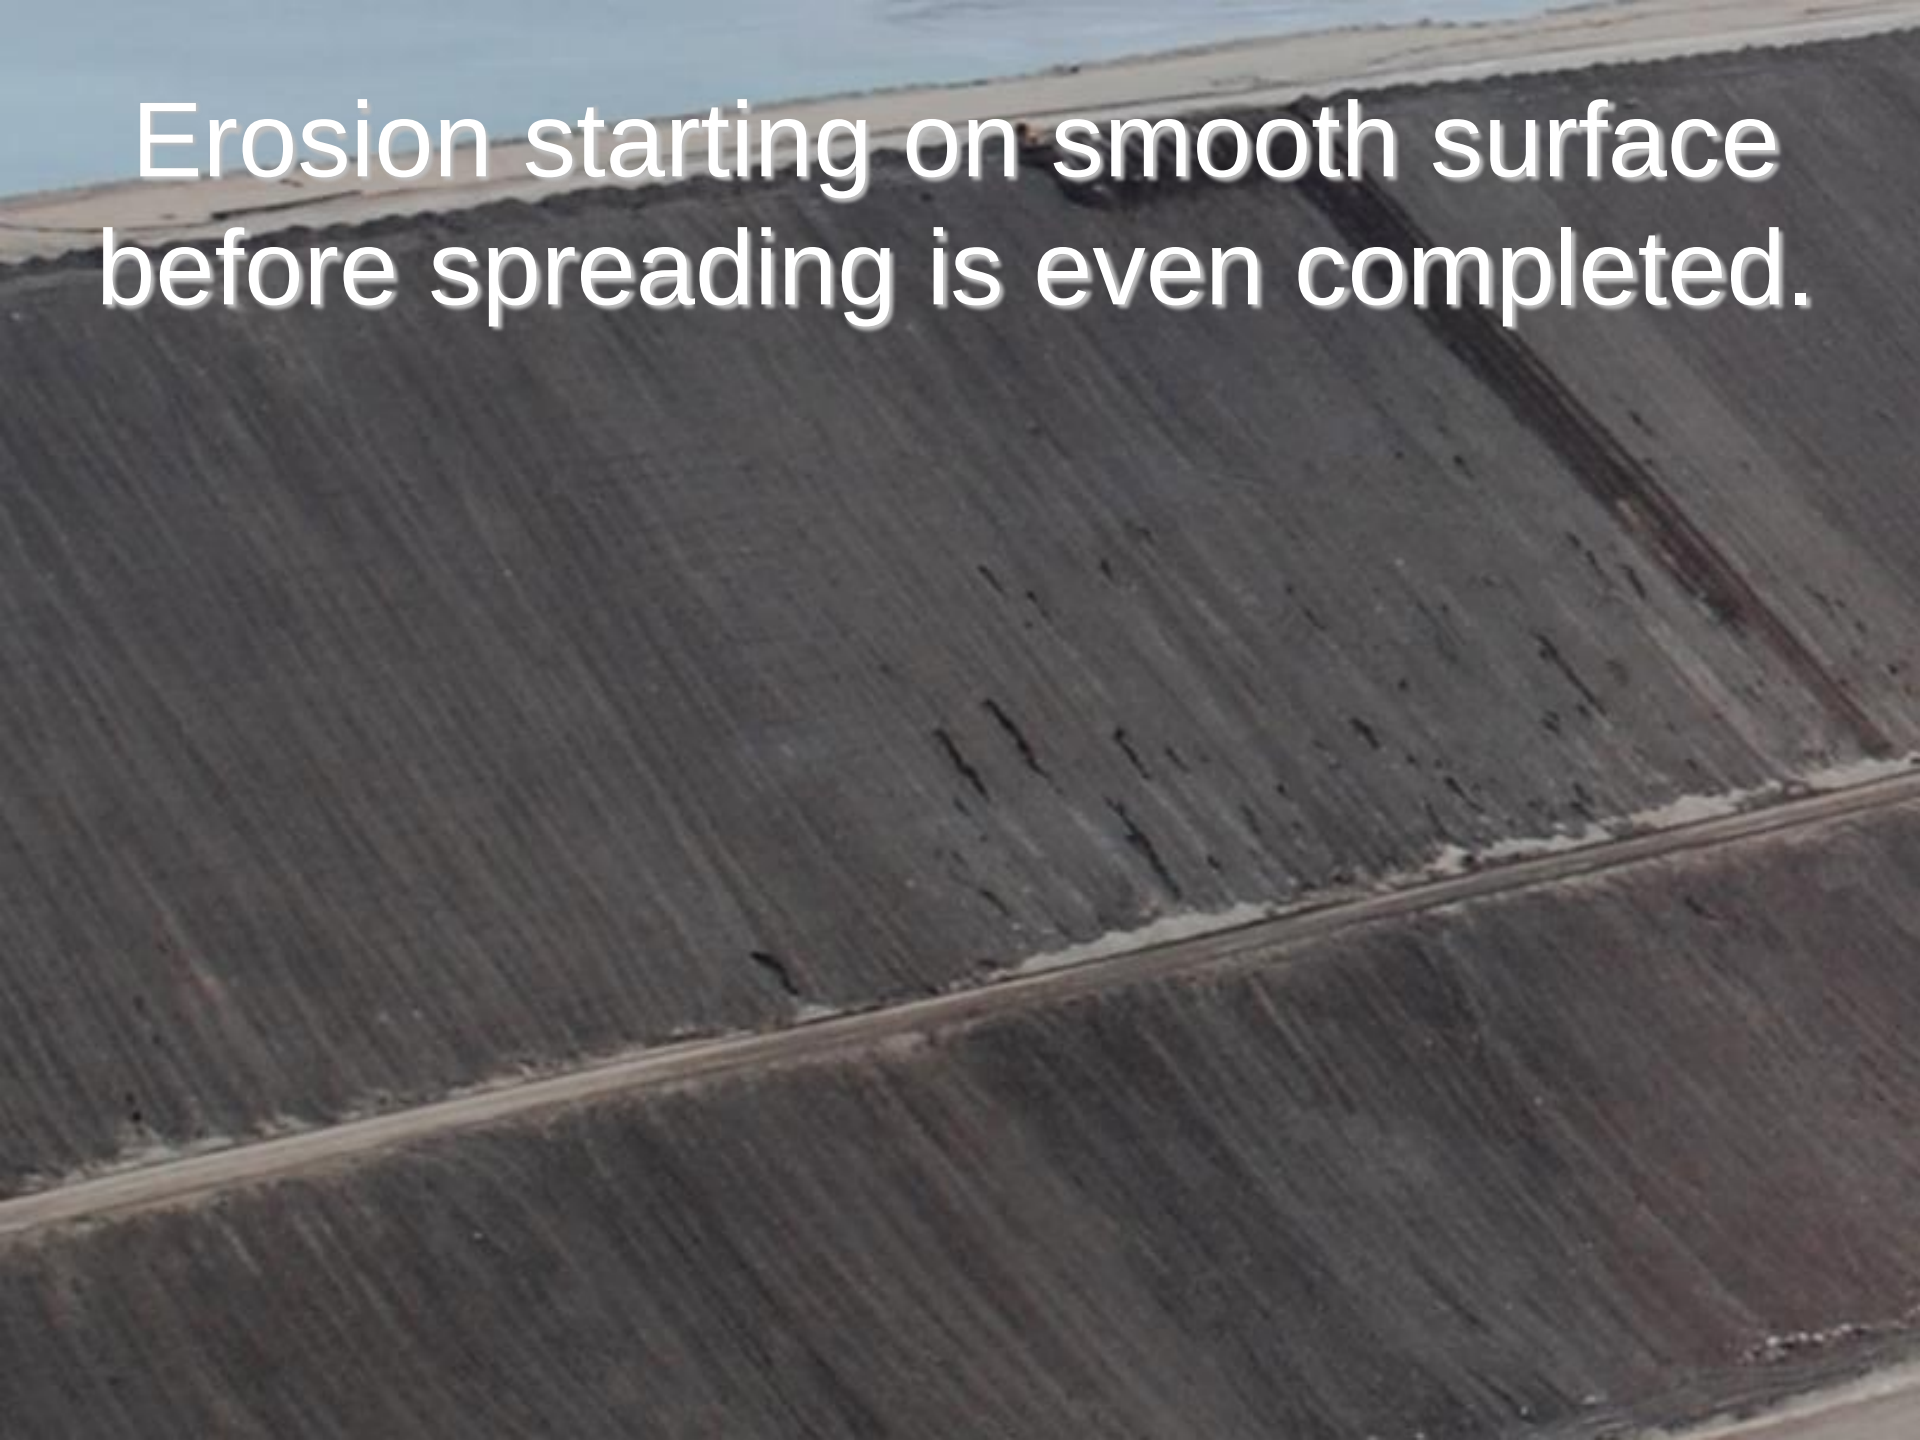
Making the surface rough and loose

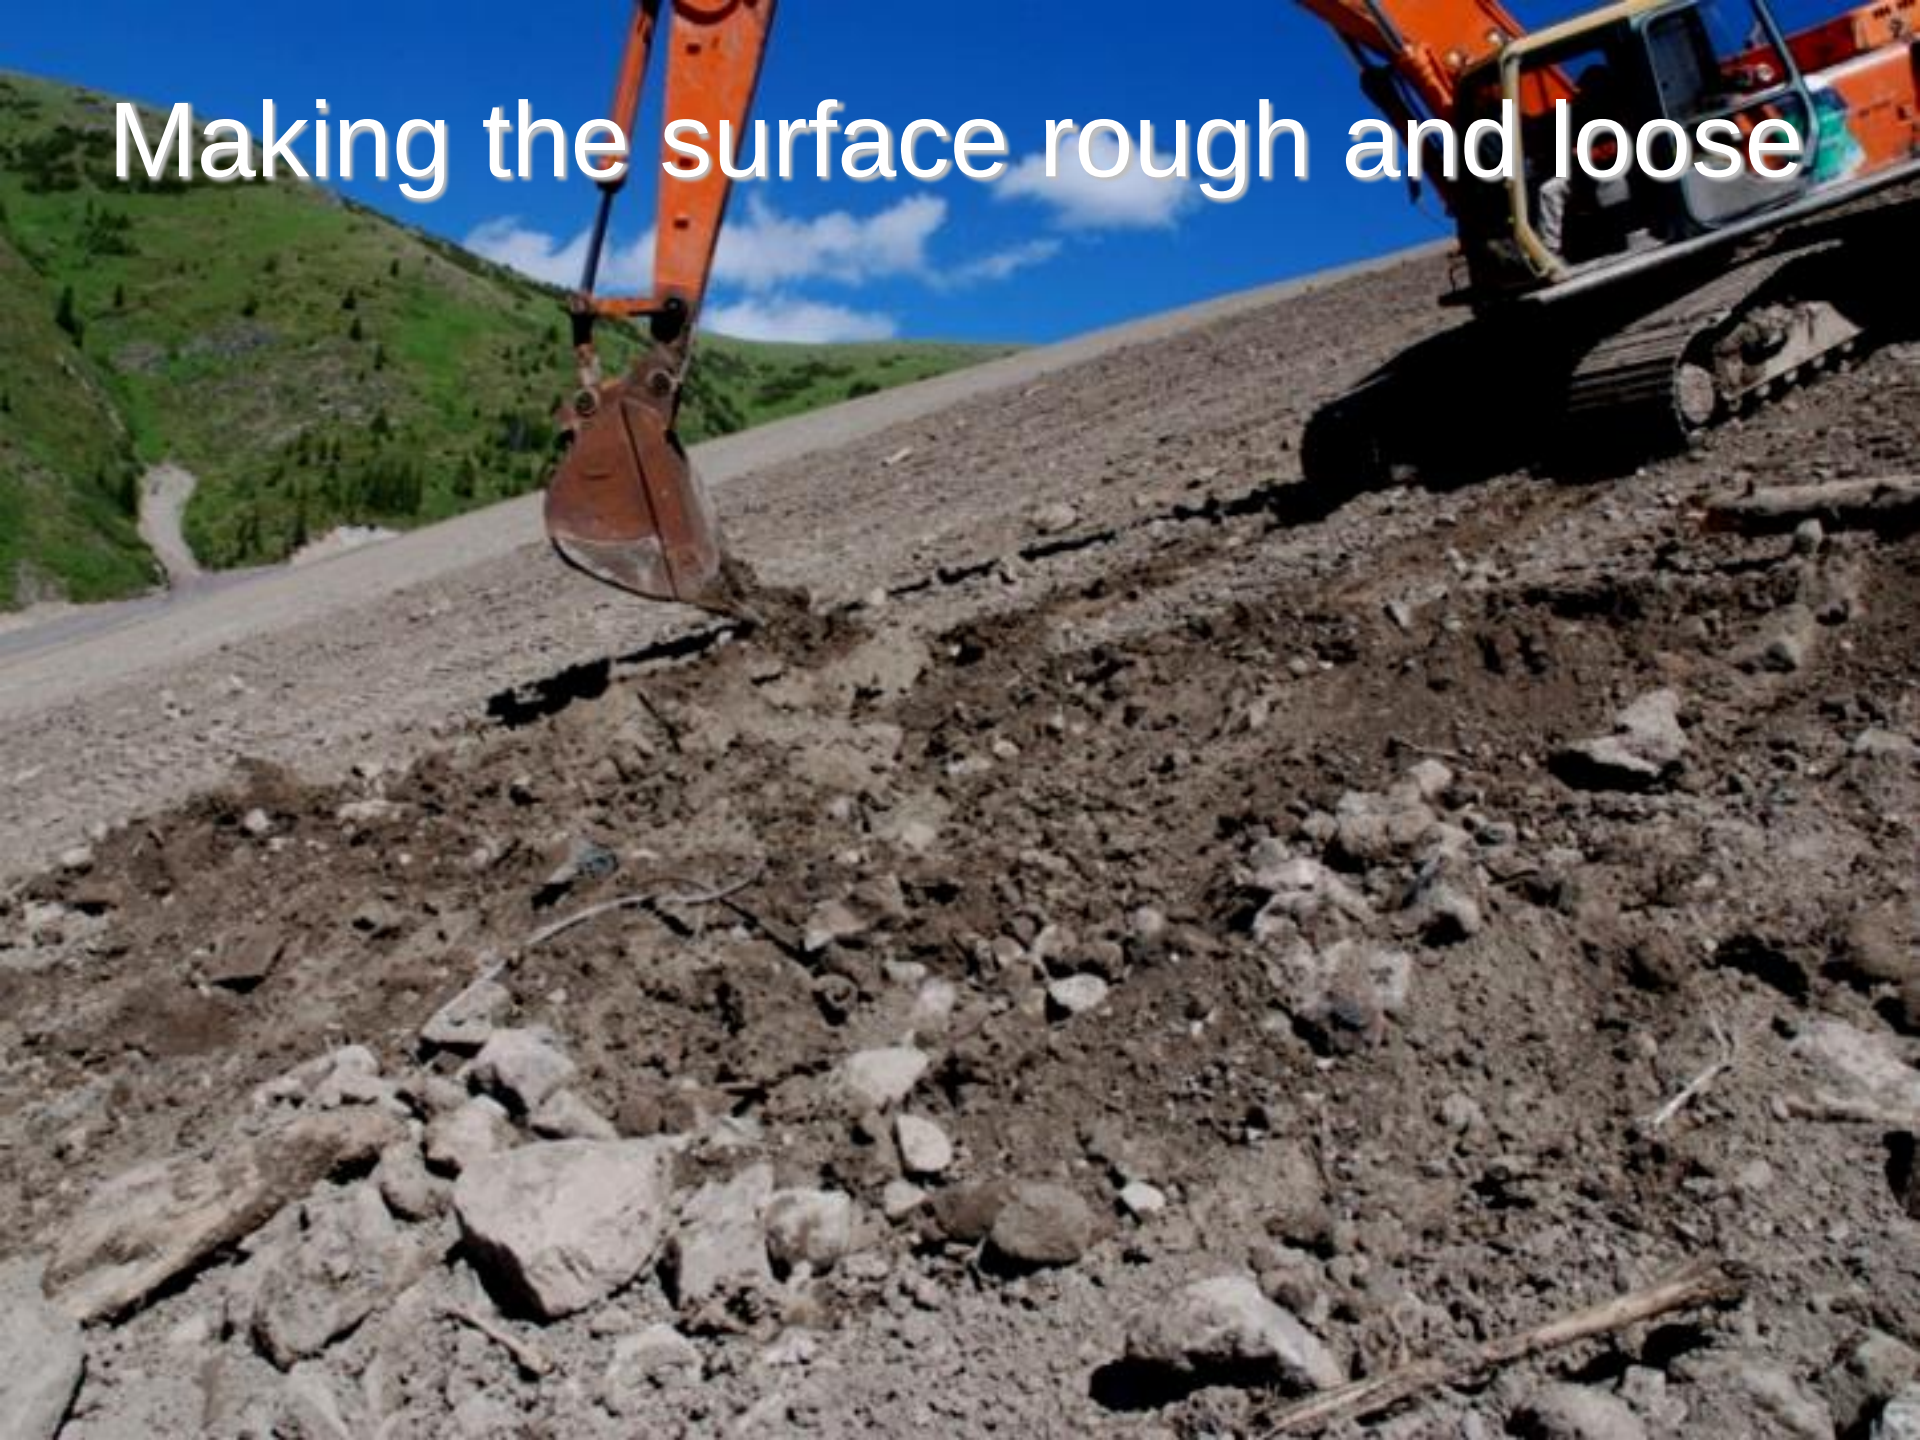
Roughened the whole surface

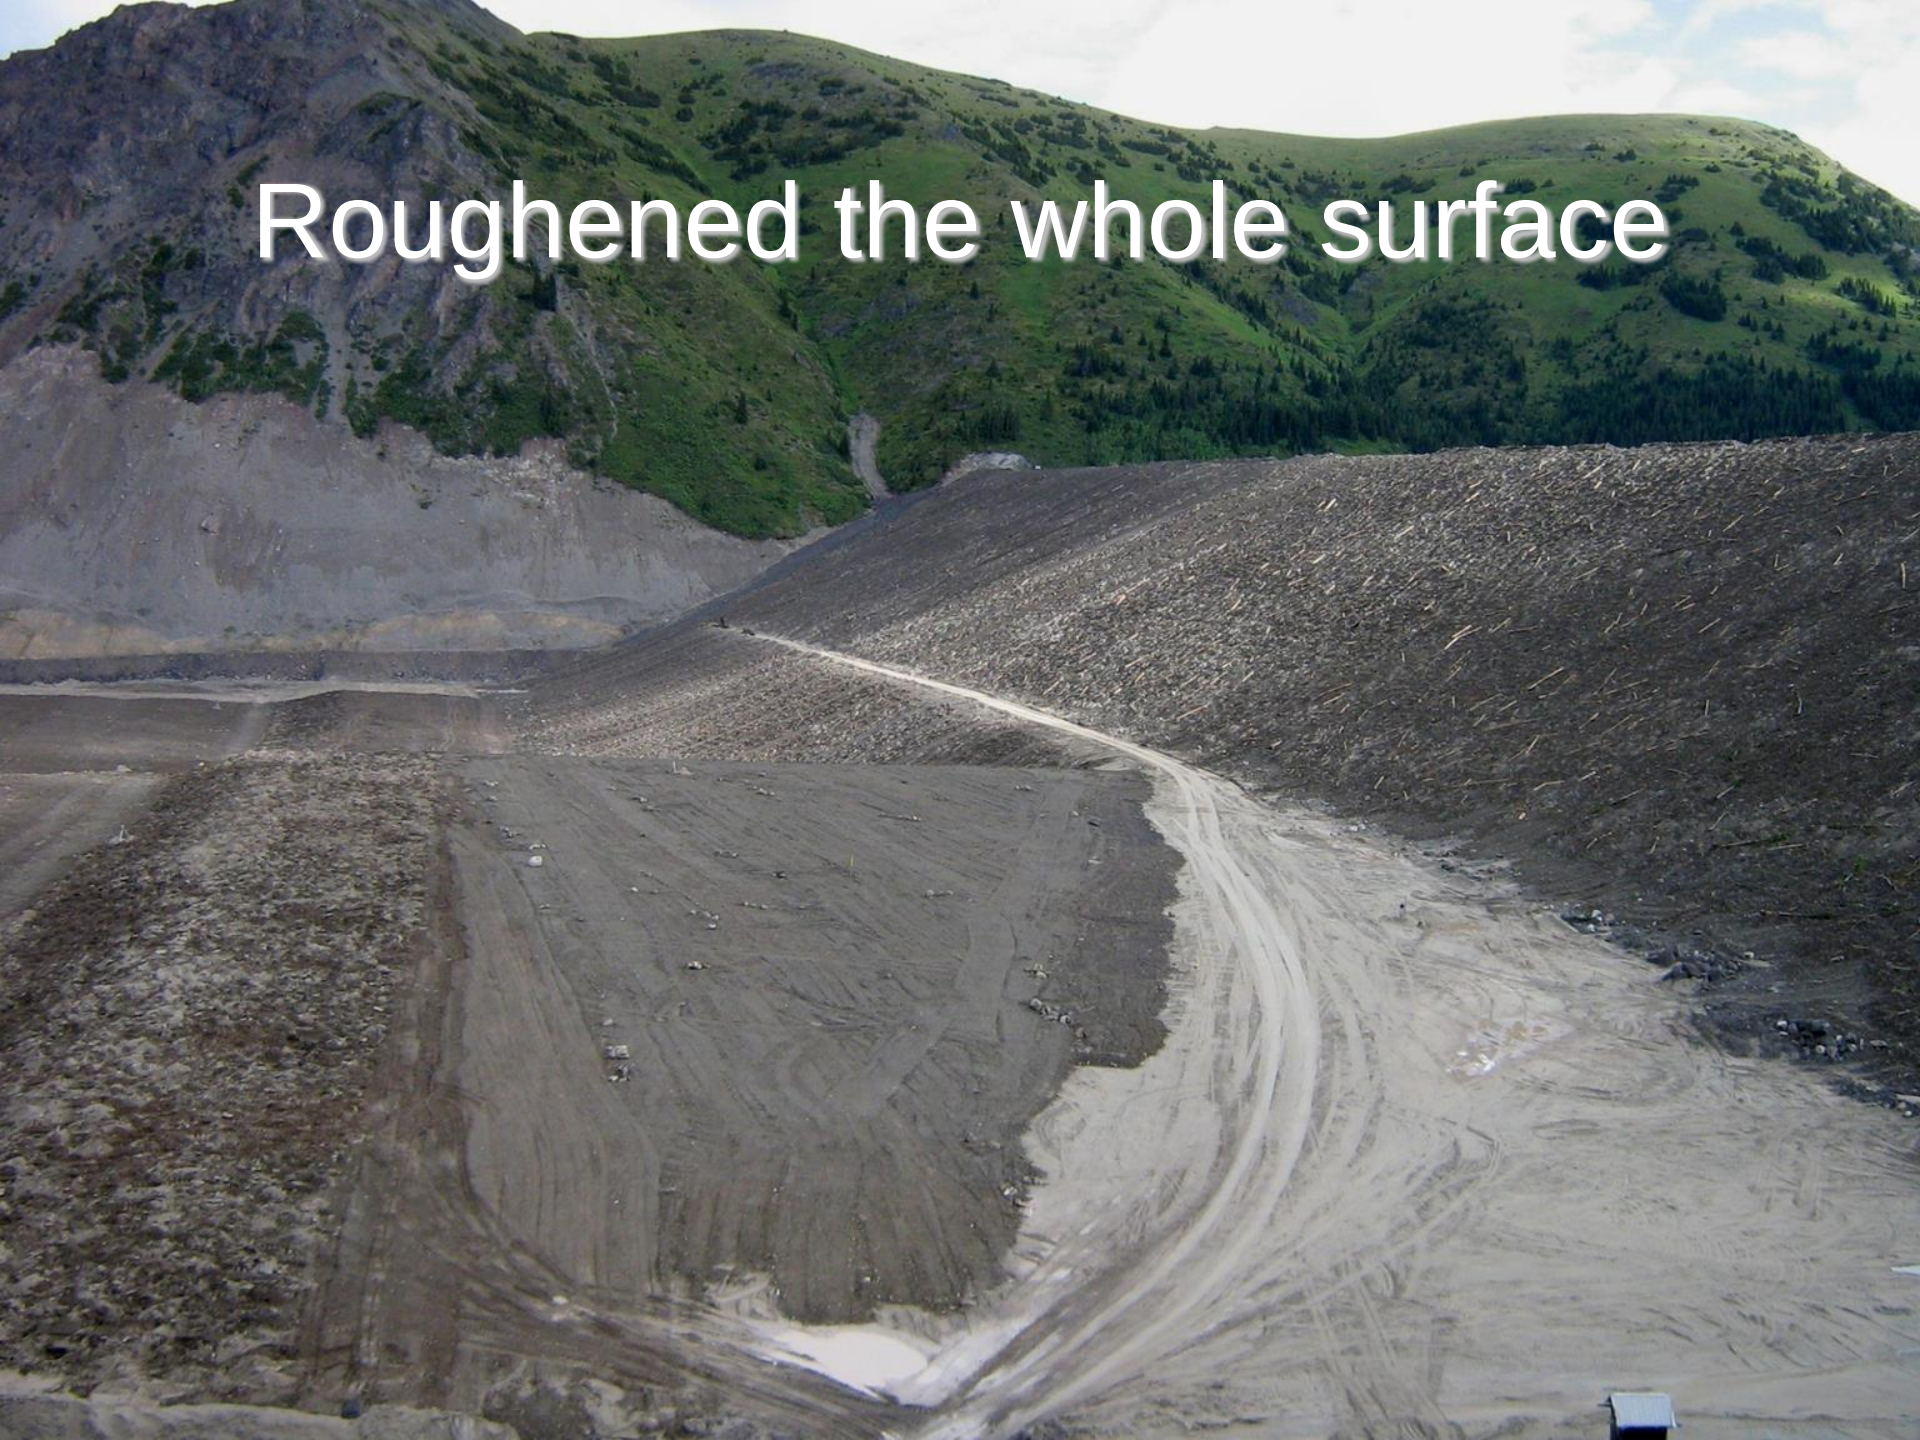
Cost of rough and loose treatment at Kemess Mine was \$715/ha while hydroseeding costs over \$2,500/ha

Making surfaces rough and loose controls erosion and enhances native species establishment.

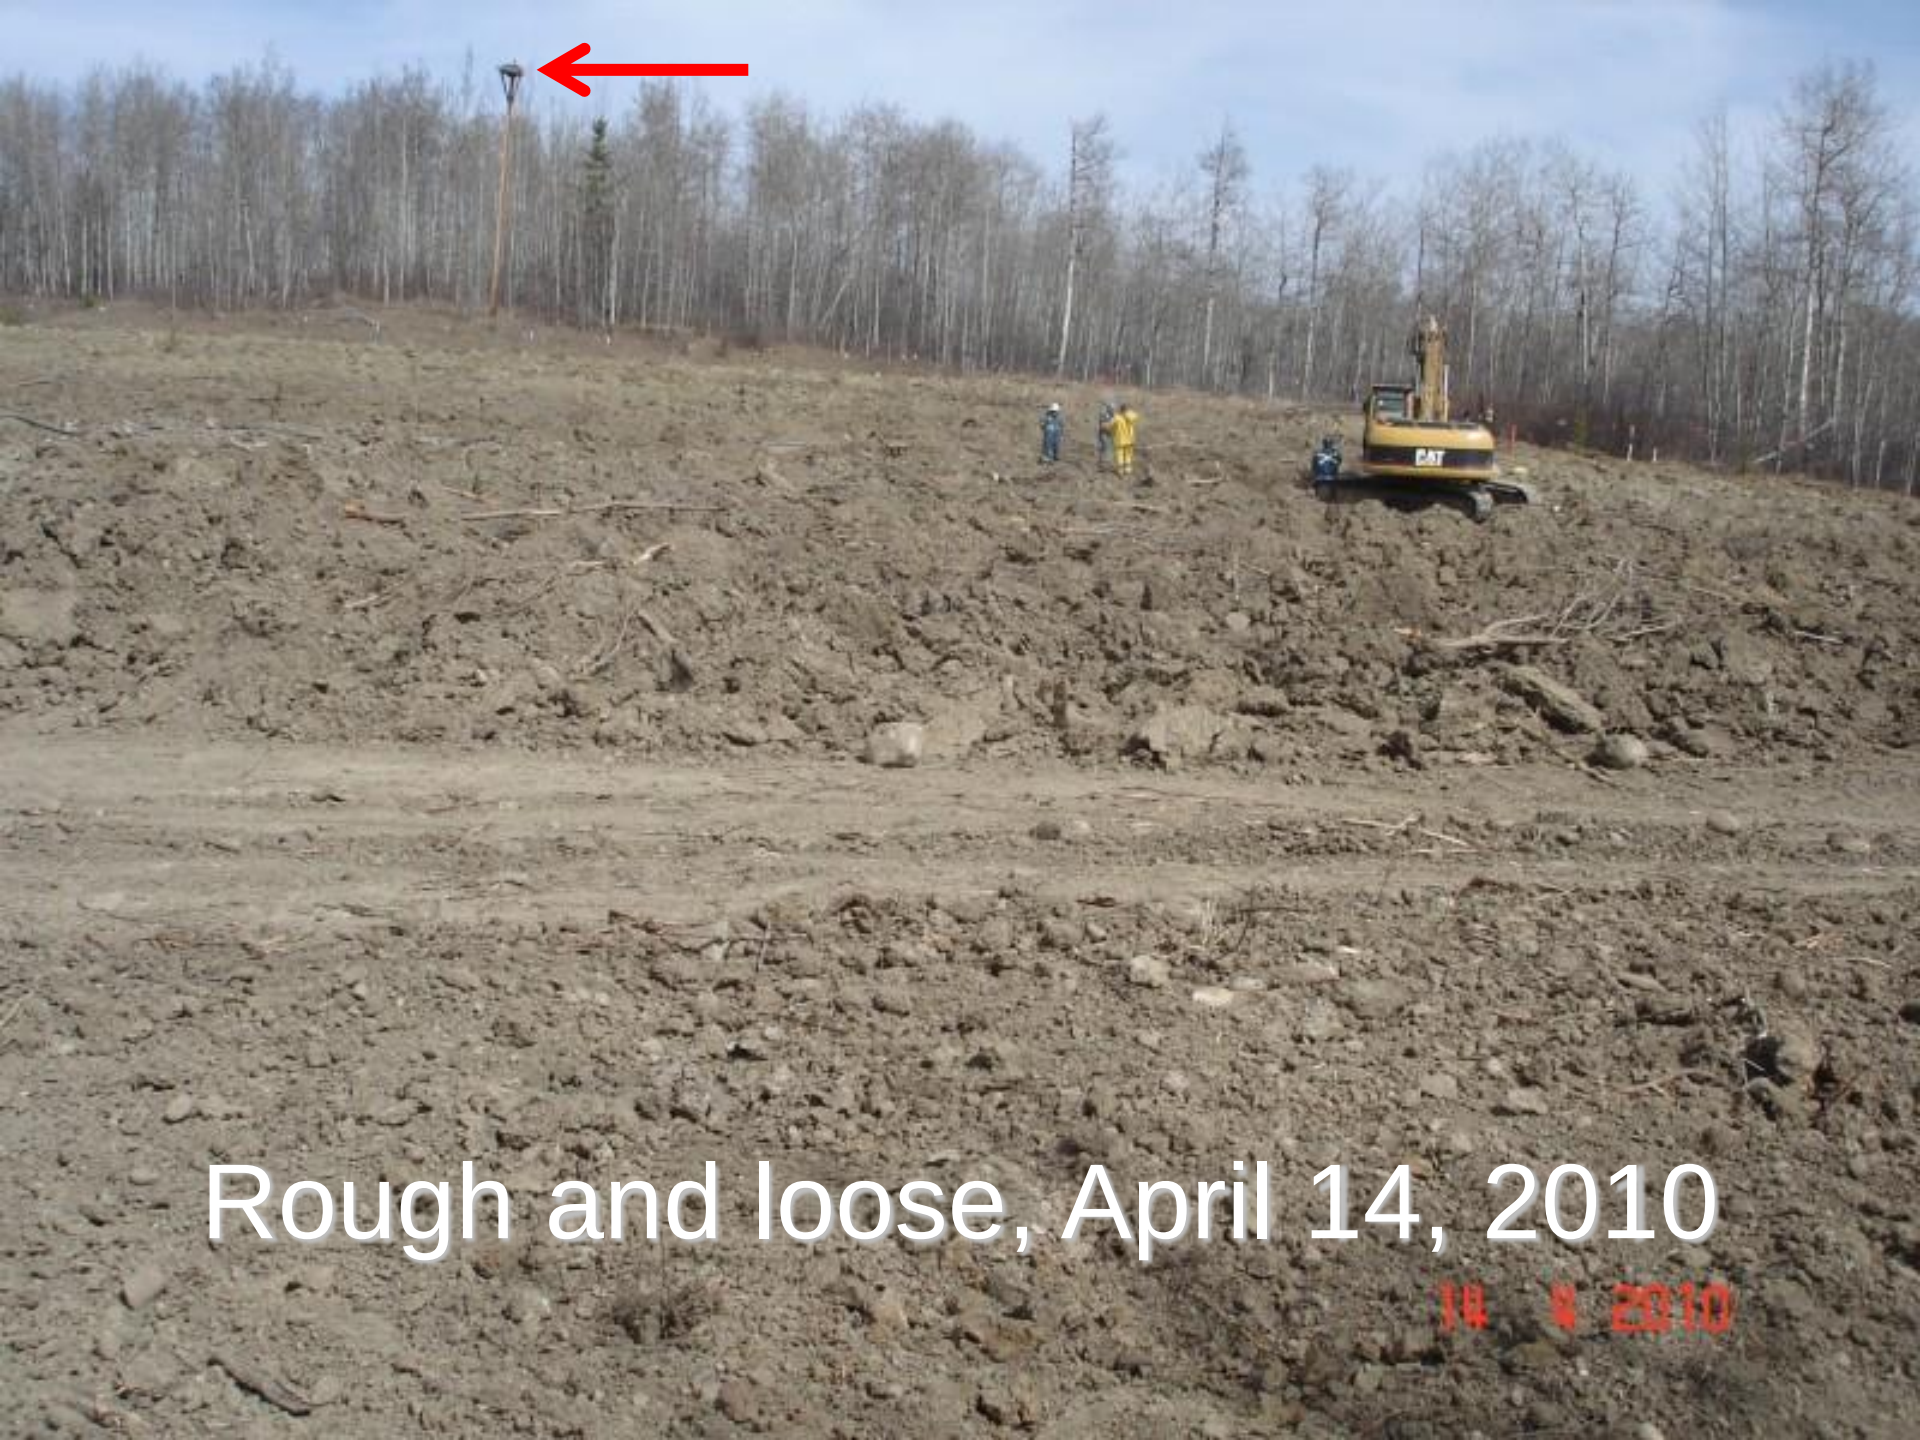
Rough and loose, April 14, 2010

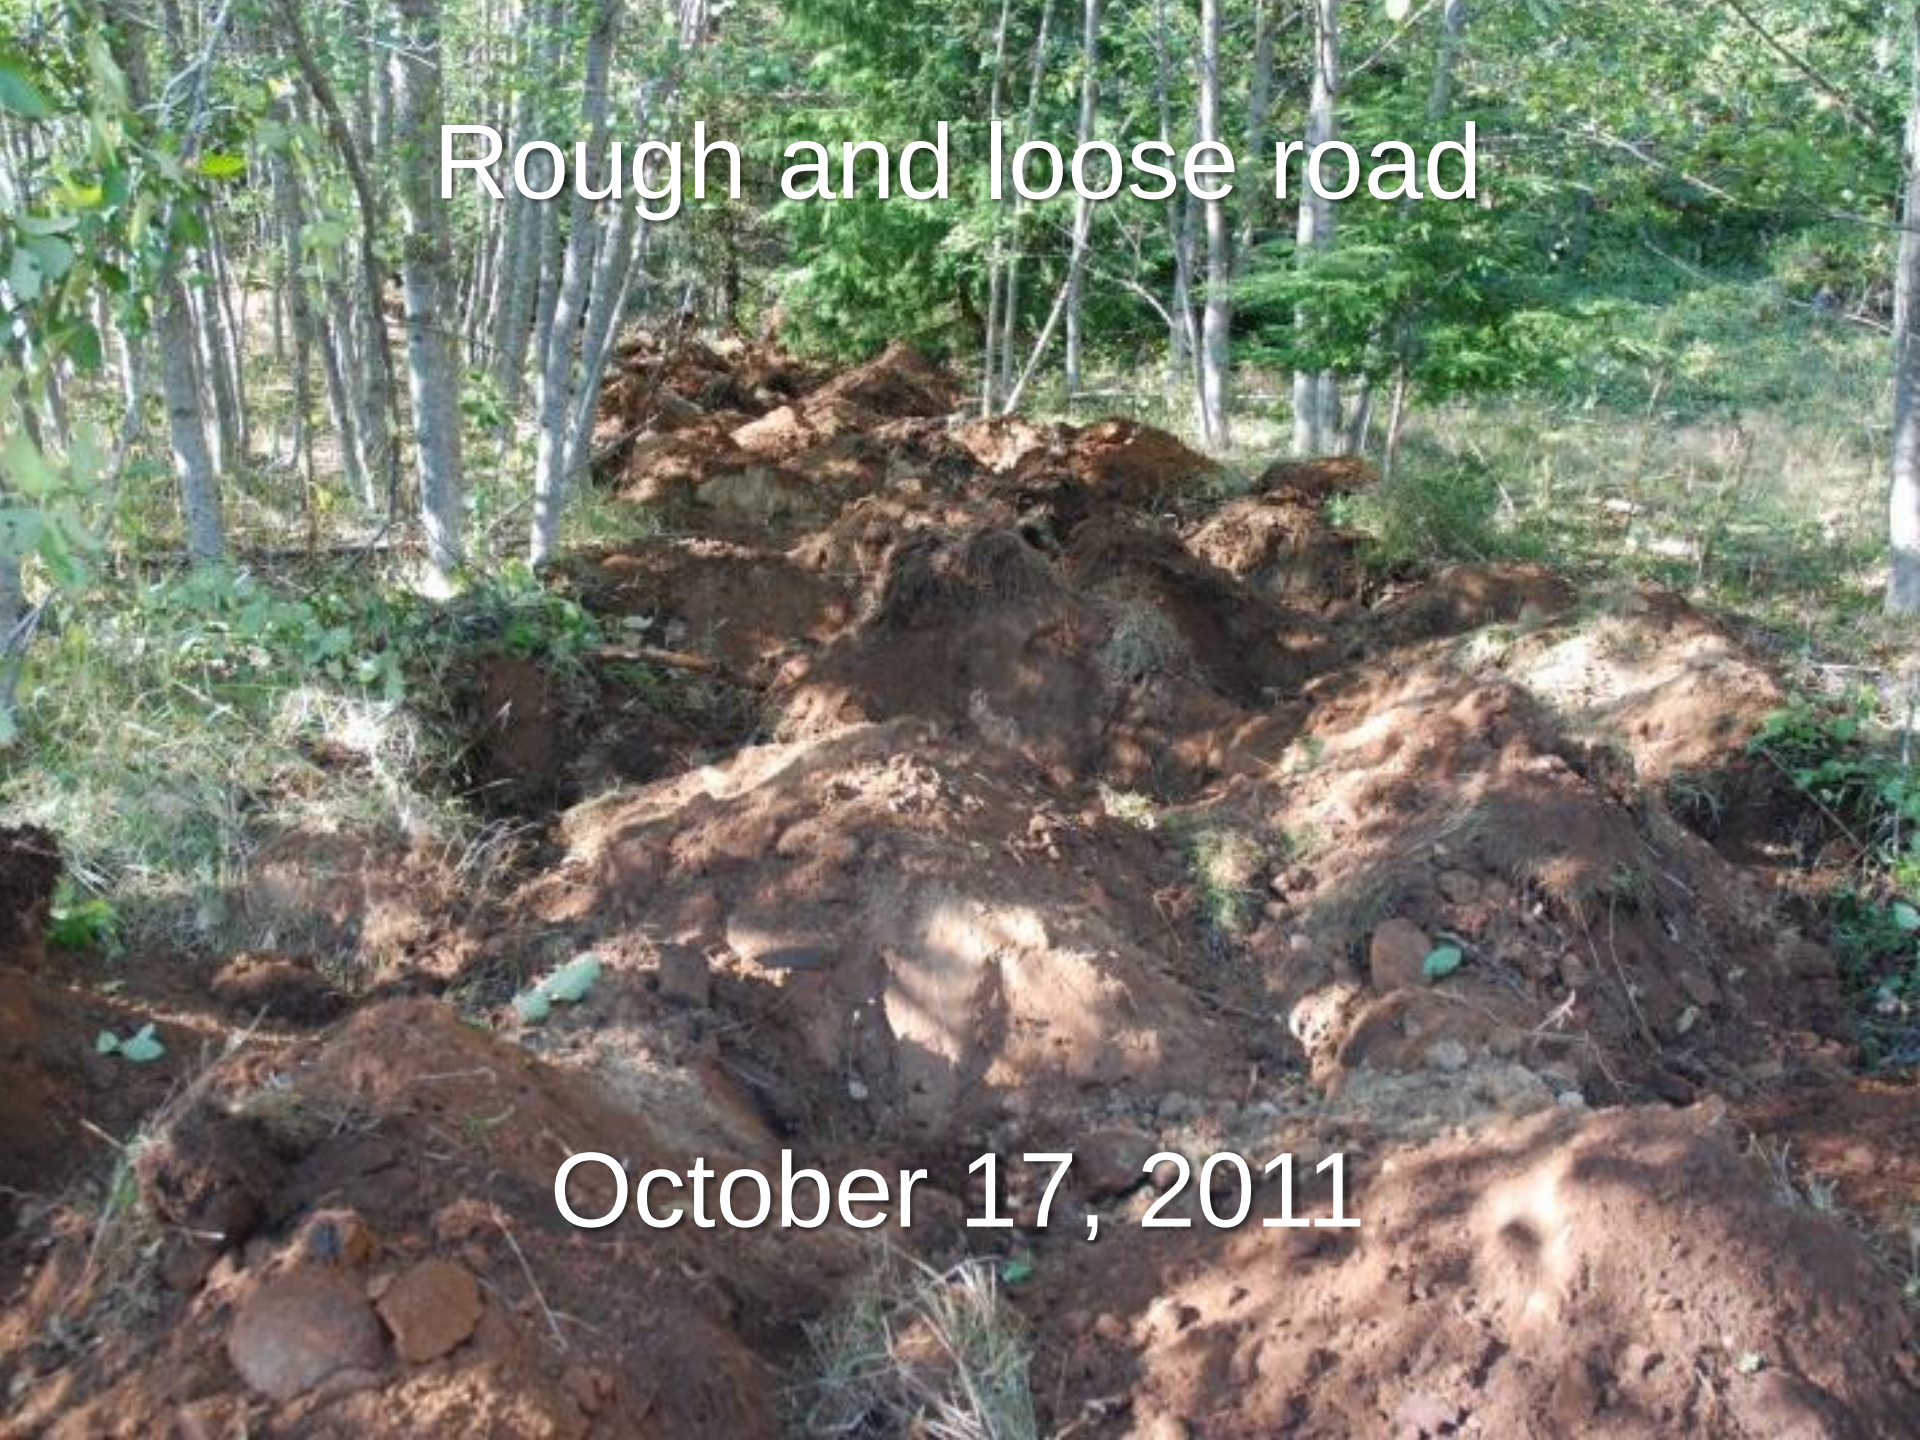
Rough and loose road

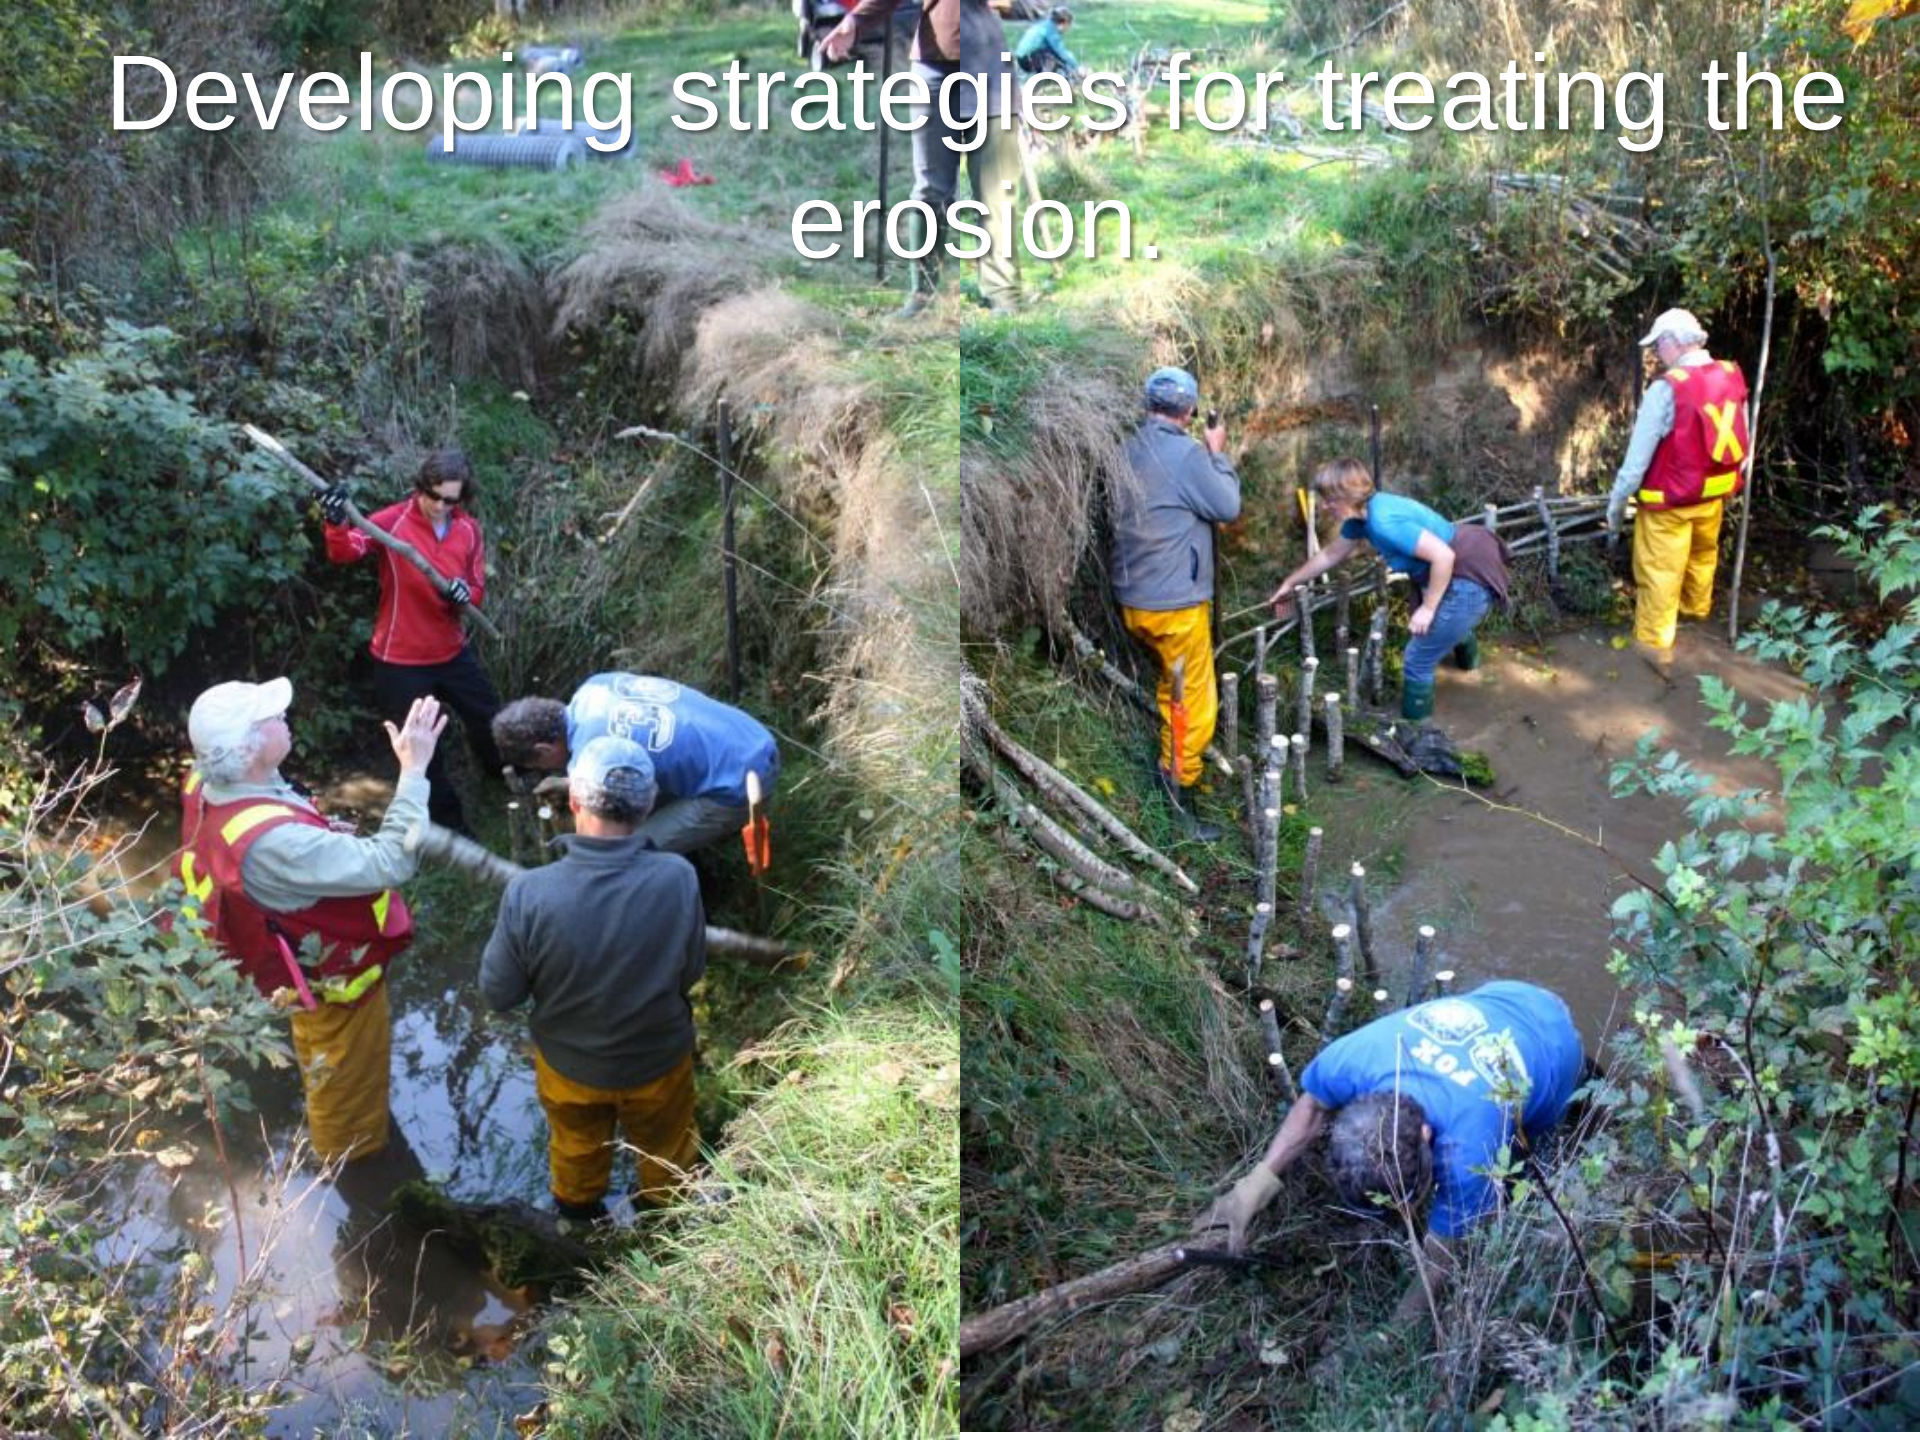
Dense live staking along the toe of the slope to slow flow velocities and live bank protection on the shore.

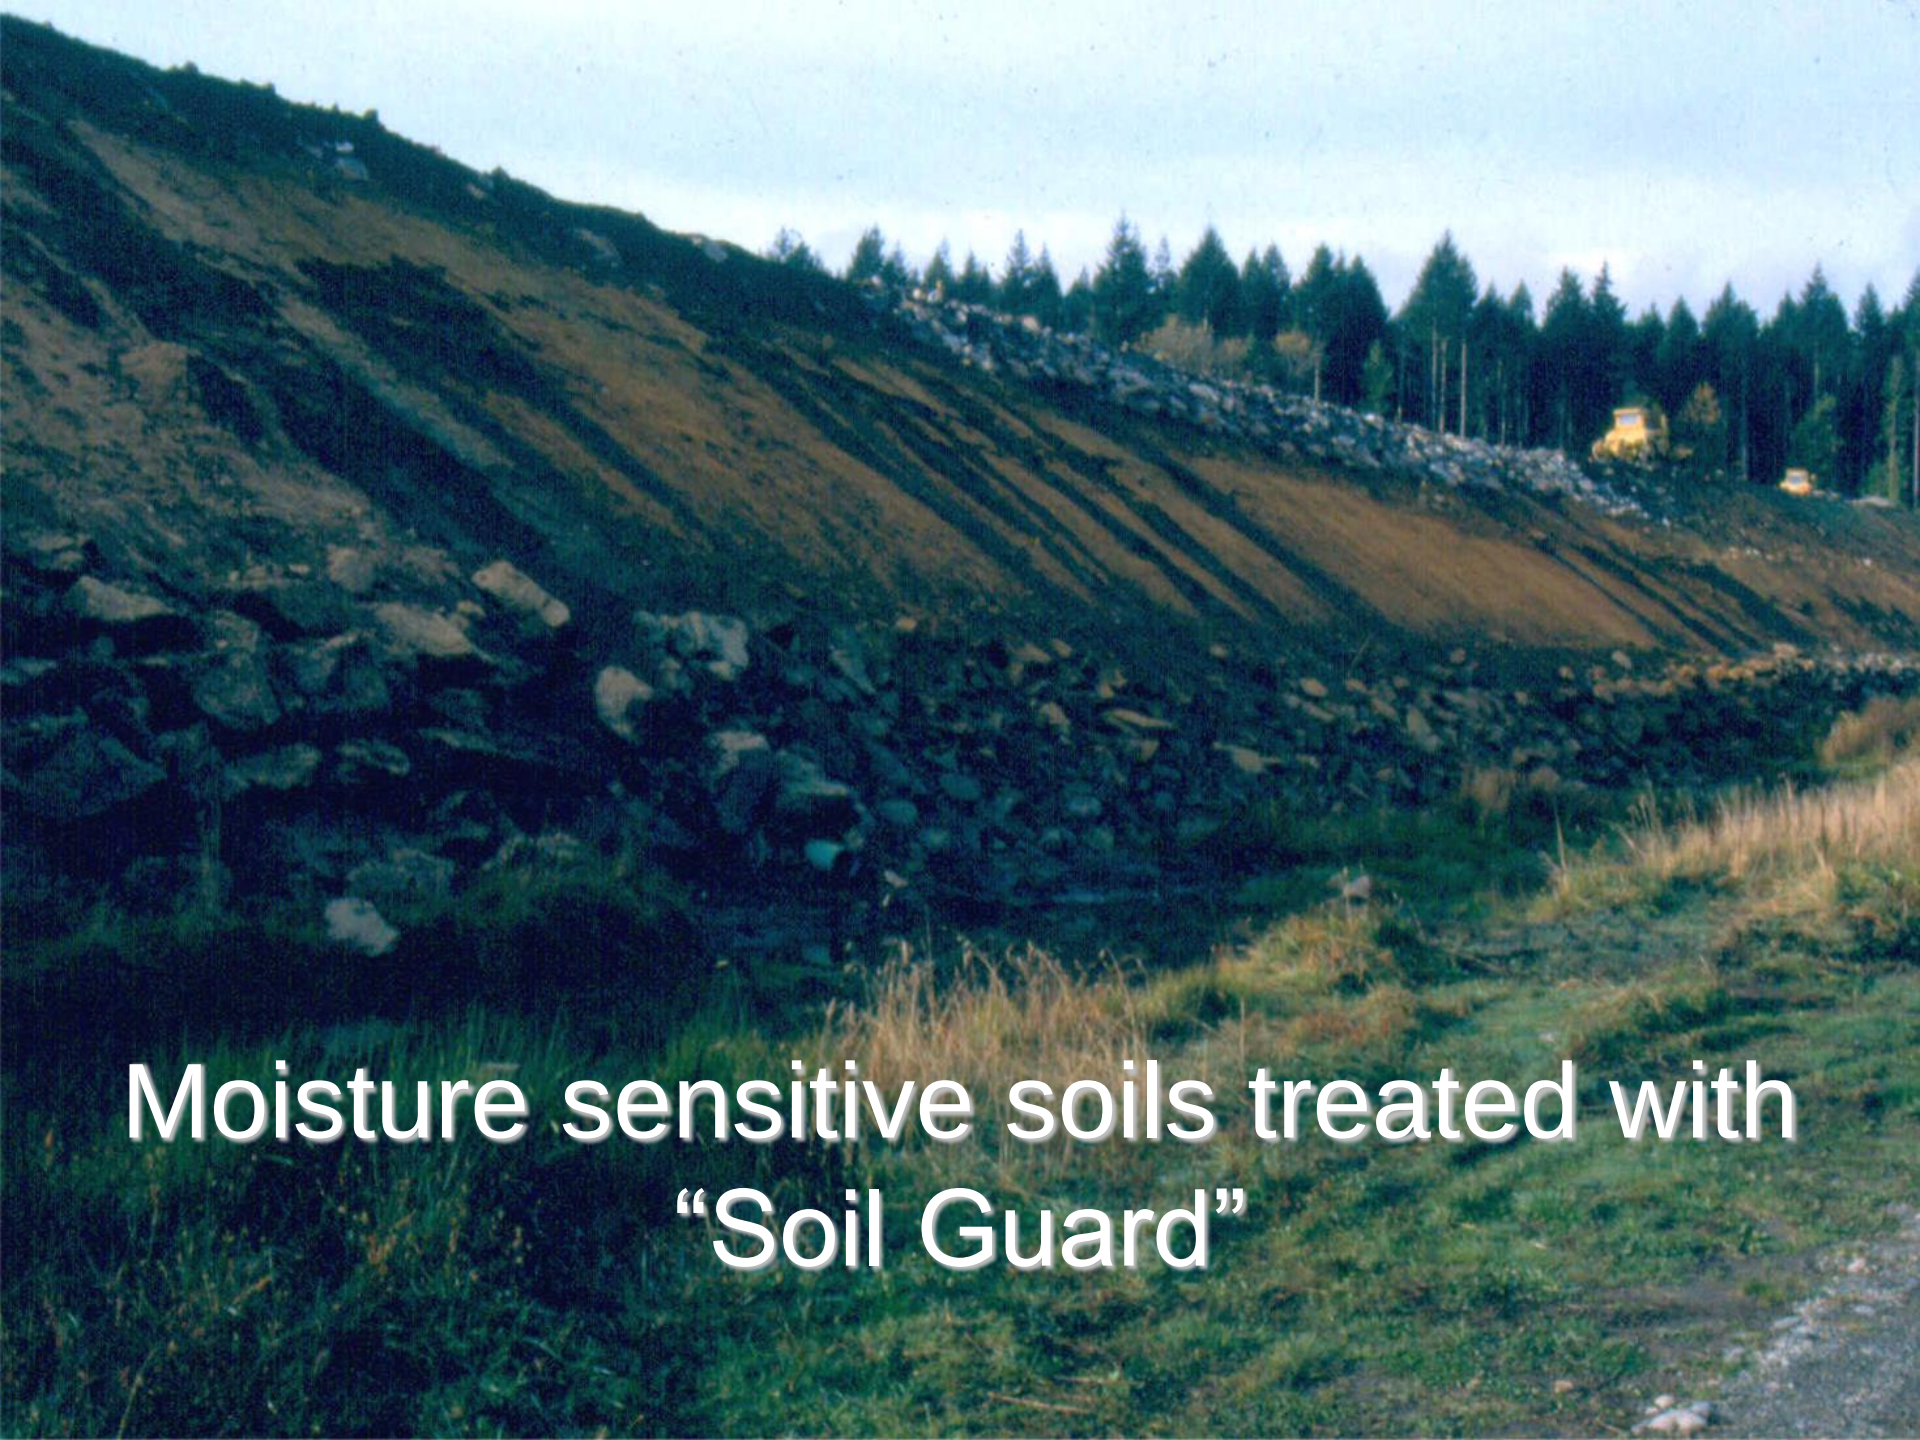
Moisture sensitive soils treated with  
“Soil Guard”
