# PHYSICAL AND MECHANICAL ACTIONS TO RESTORE SOIL STRUCTURE

David Polster, M.Sc. R.P.Bio.  
Polster Environmental Services Ltd.

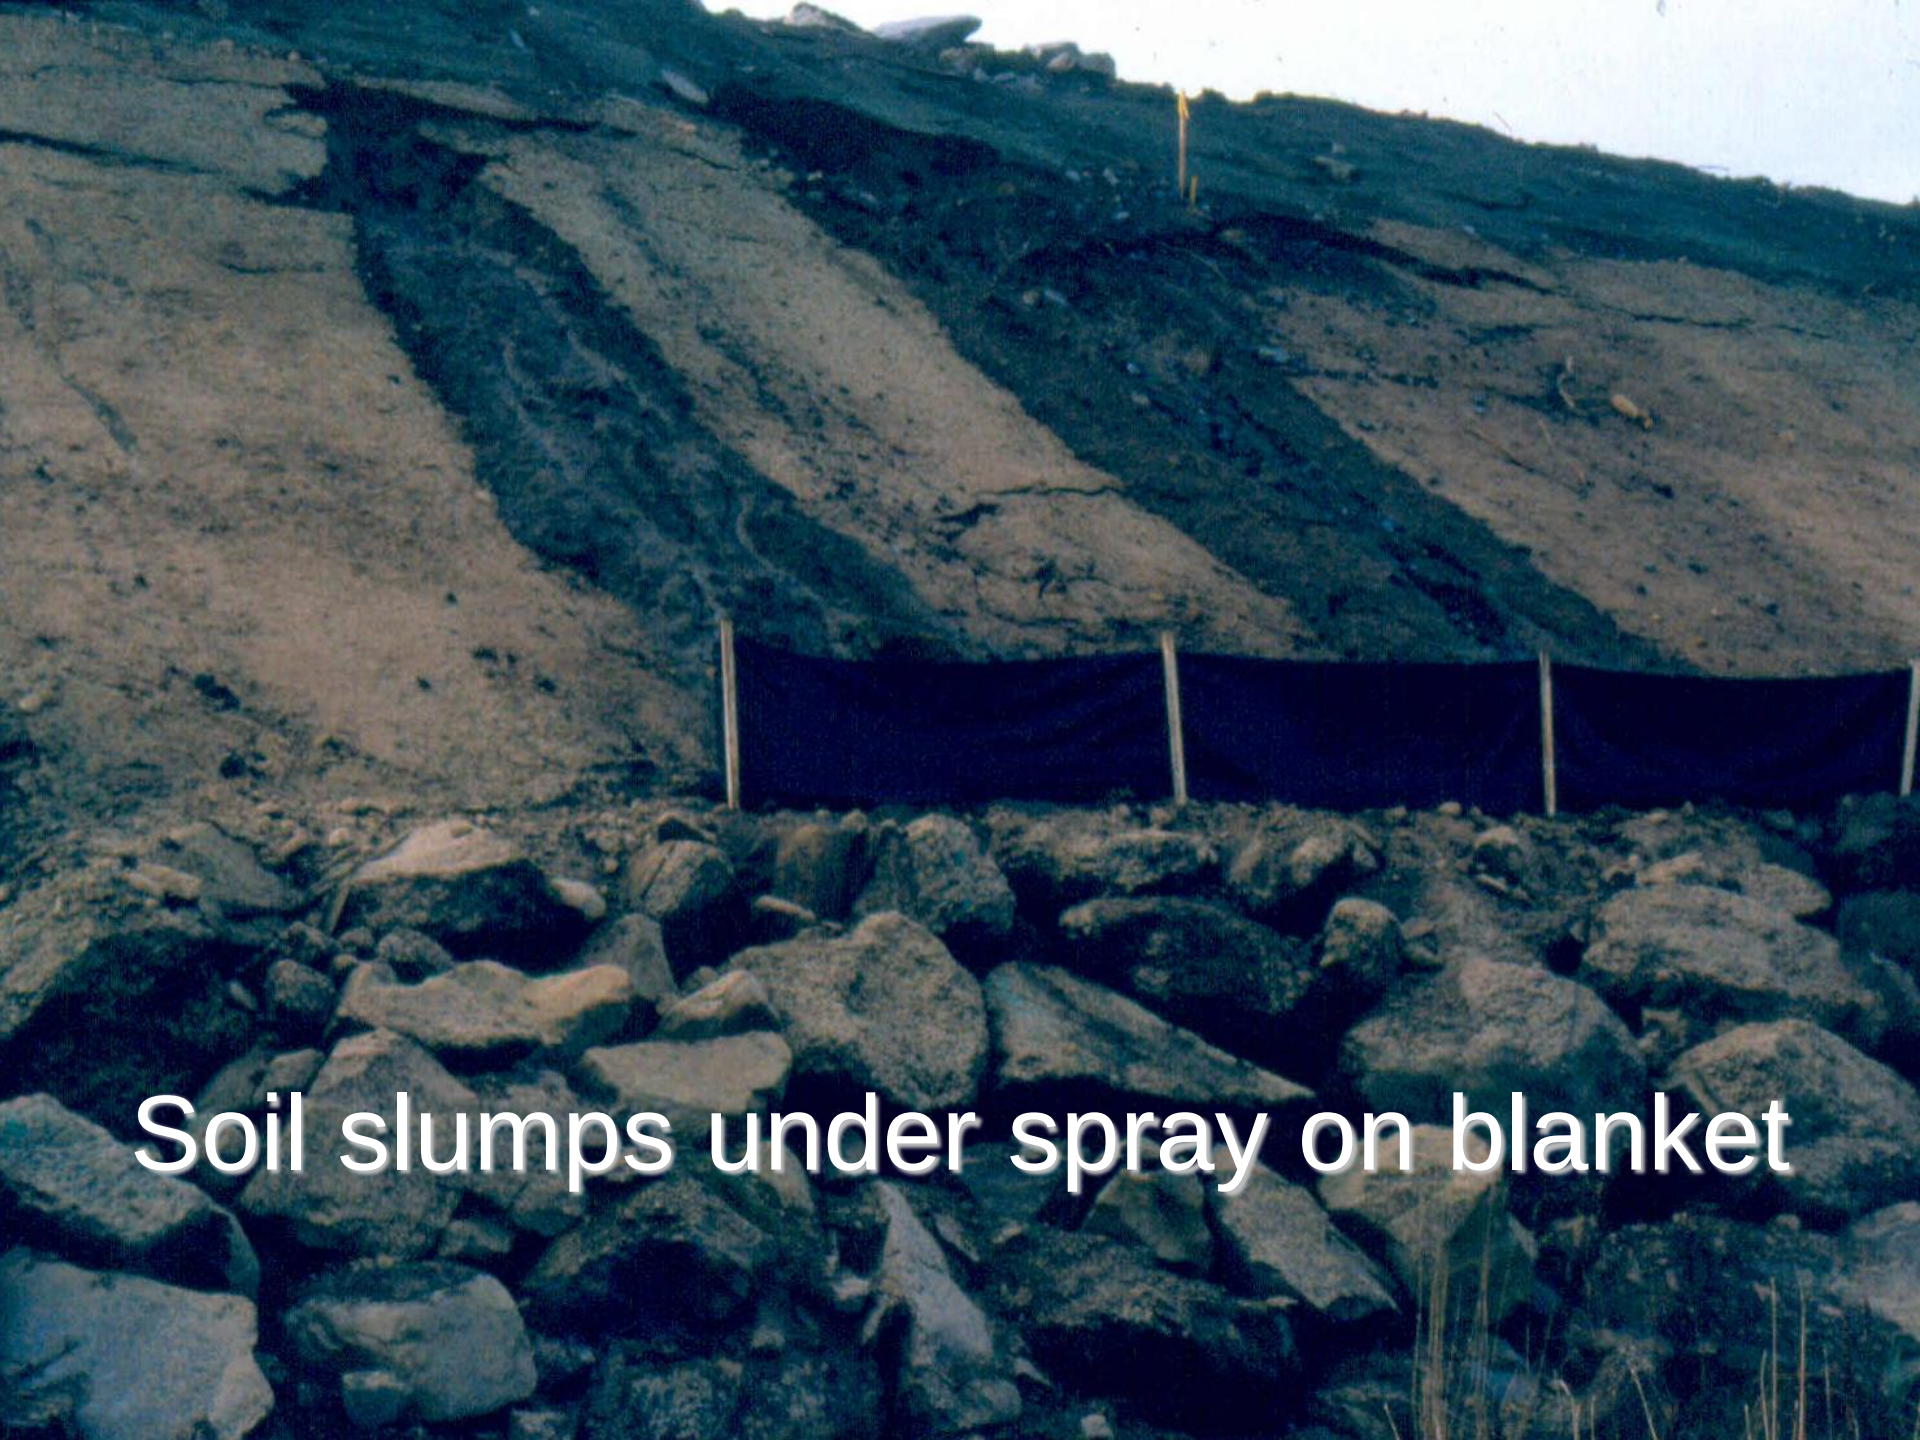
Soil slumps under spray on blanket

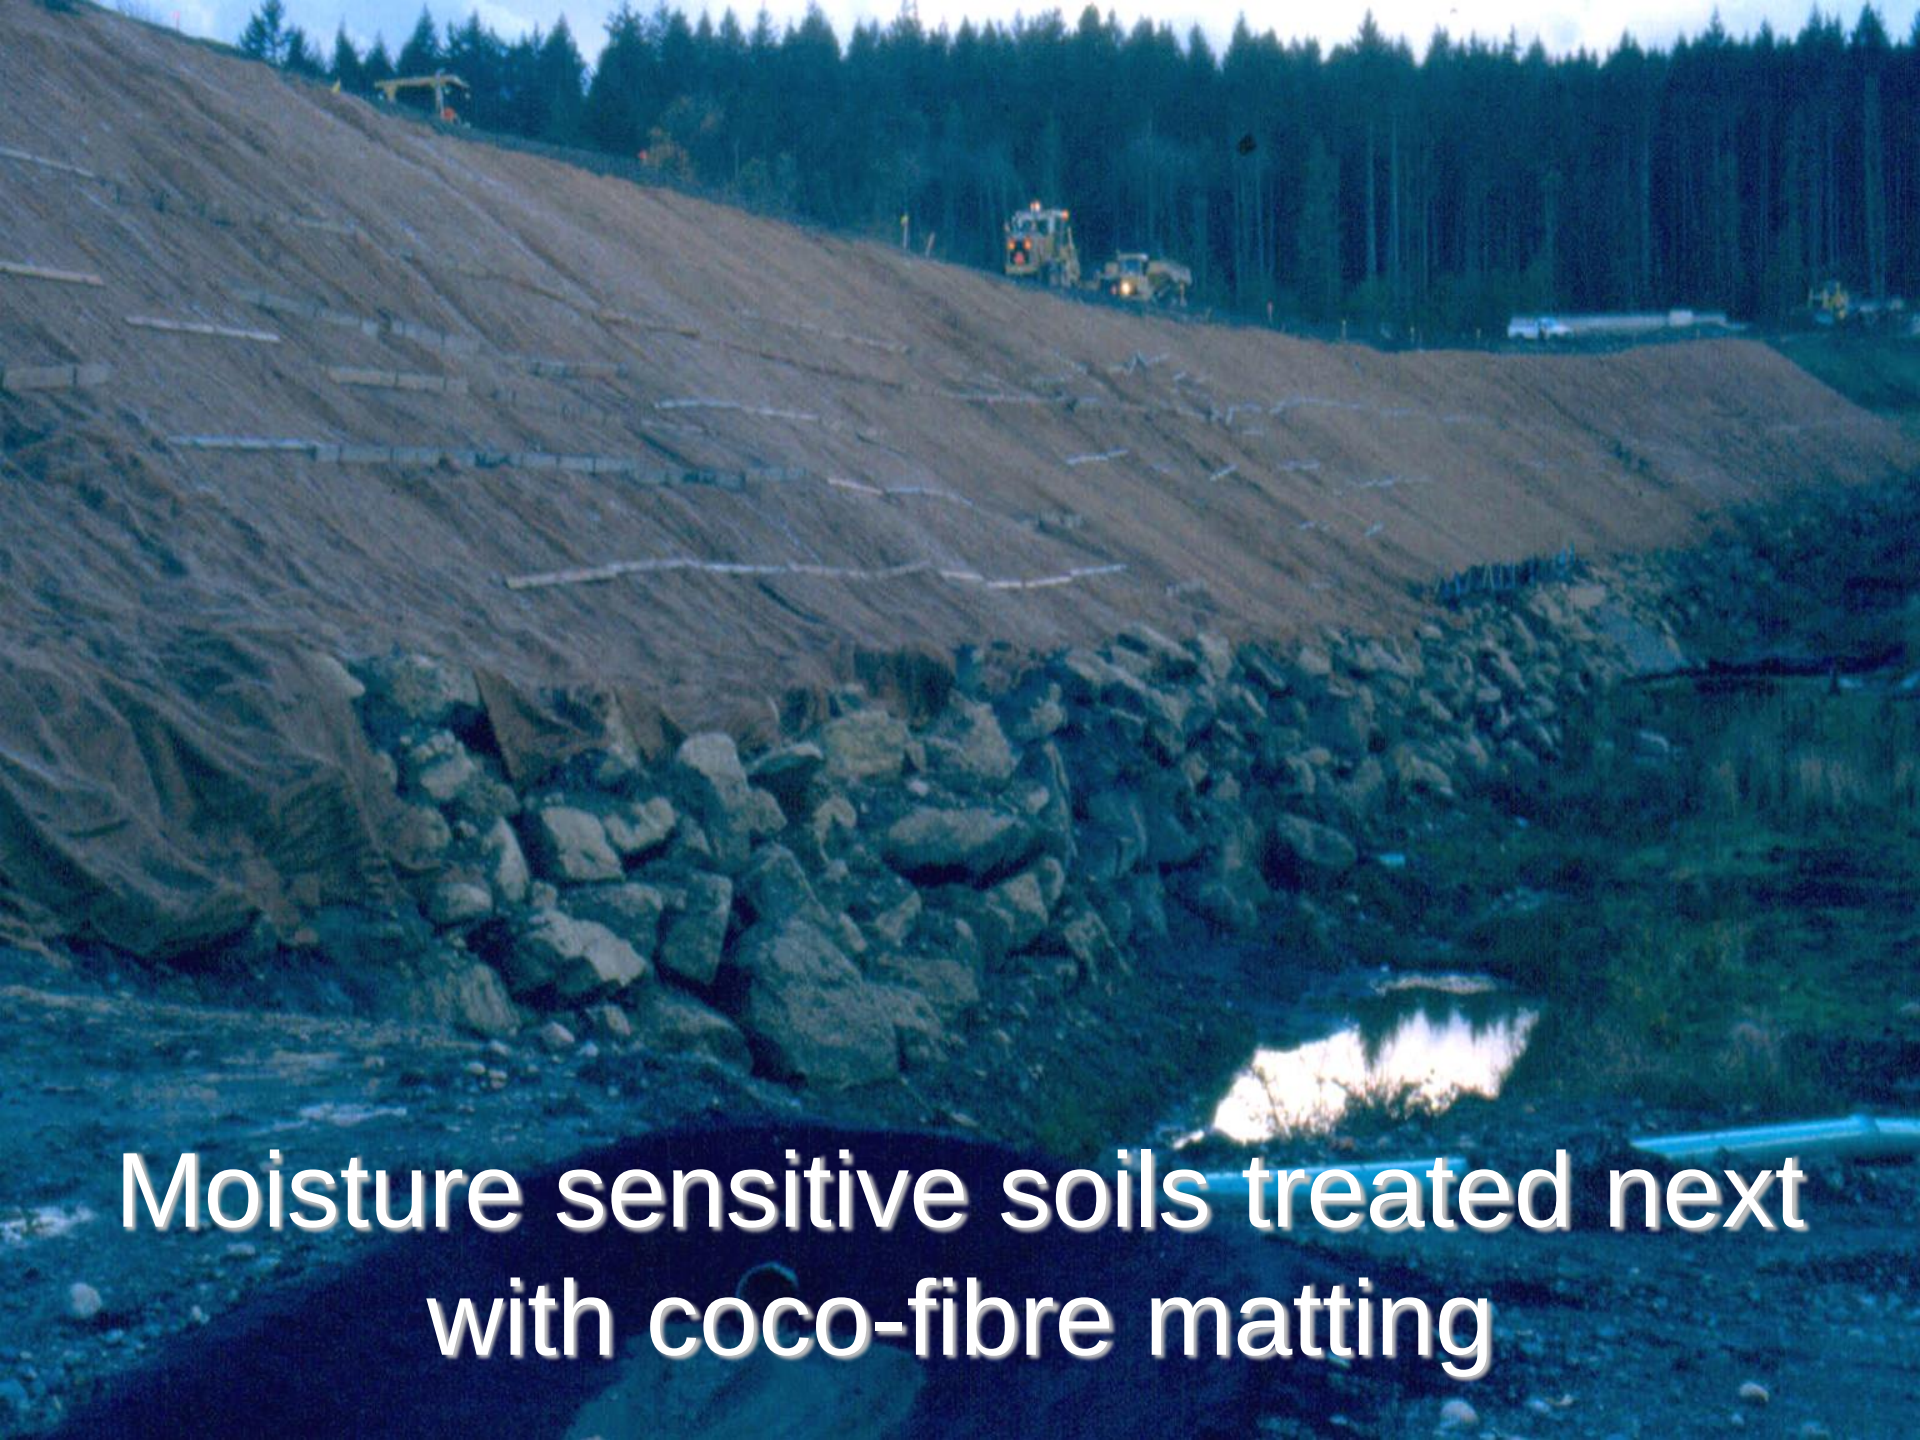
Moisture sensitive soils treated next  
with coco-fibre matting

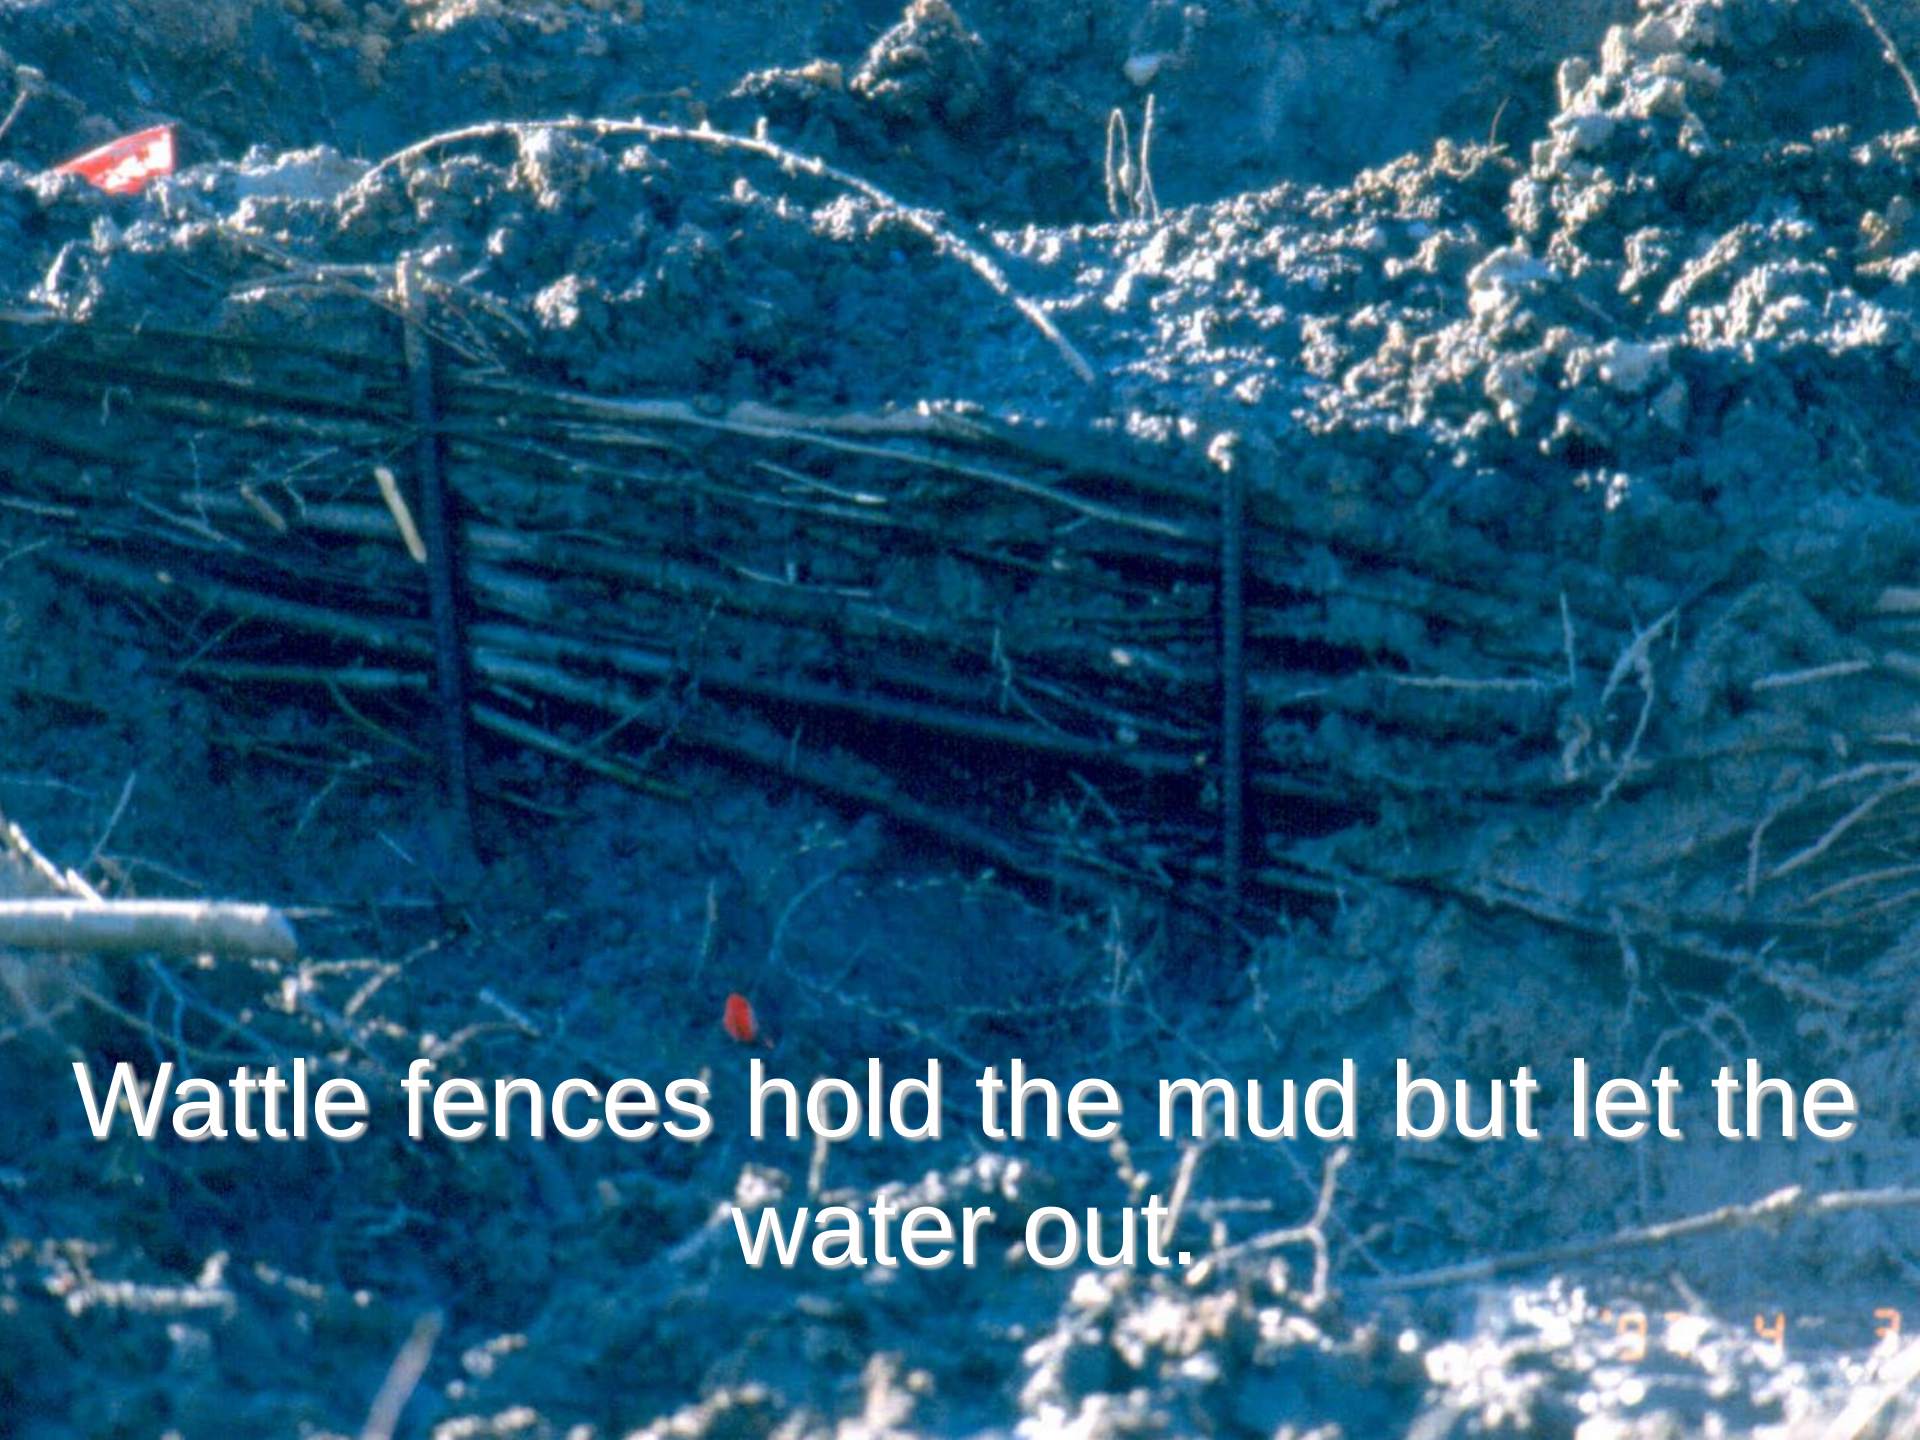
Wattle fences hold the mud but let the water out.

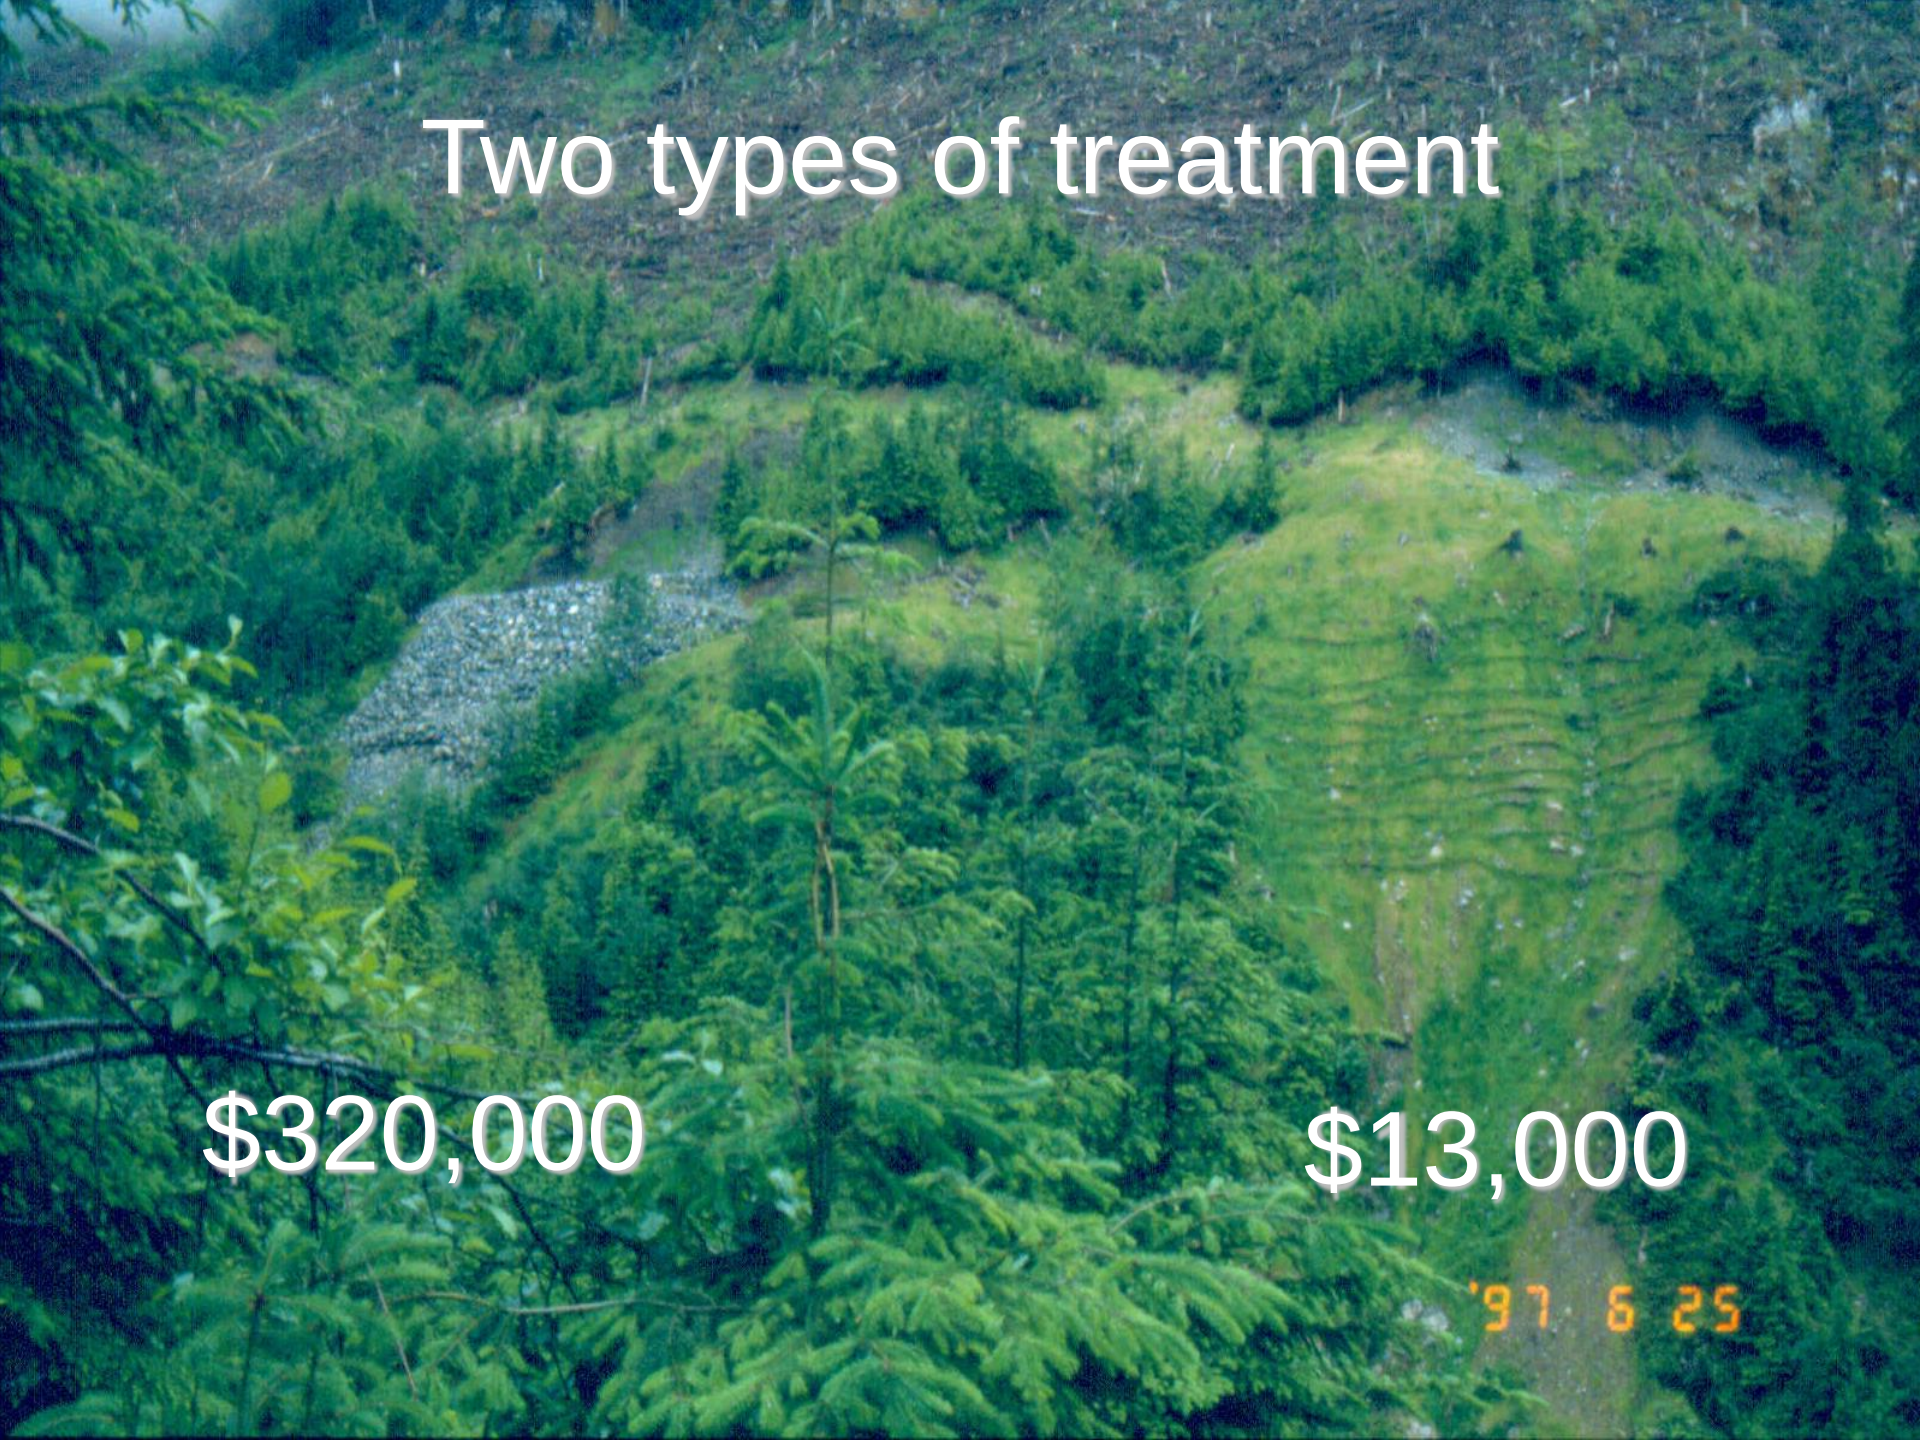
# Two types of treatment

\$320,000

\$13,000

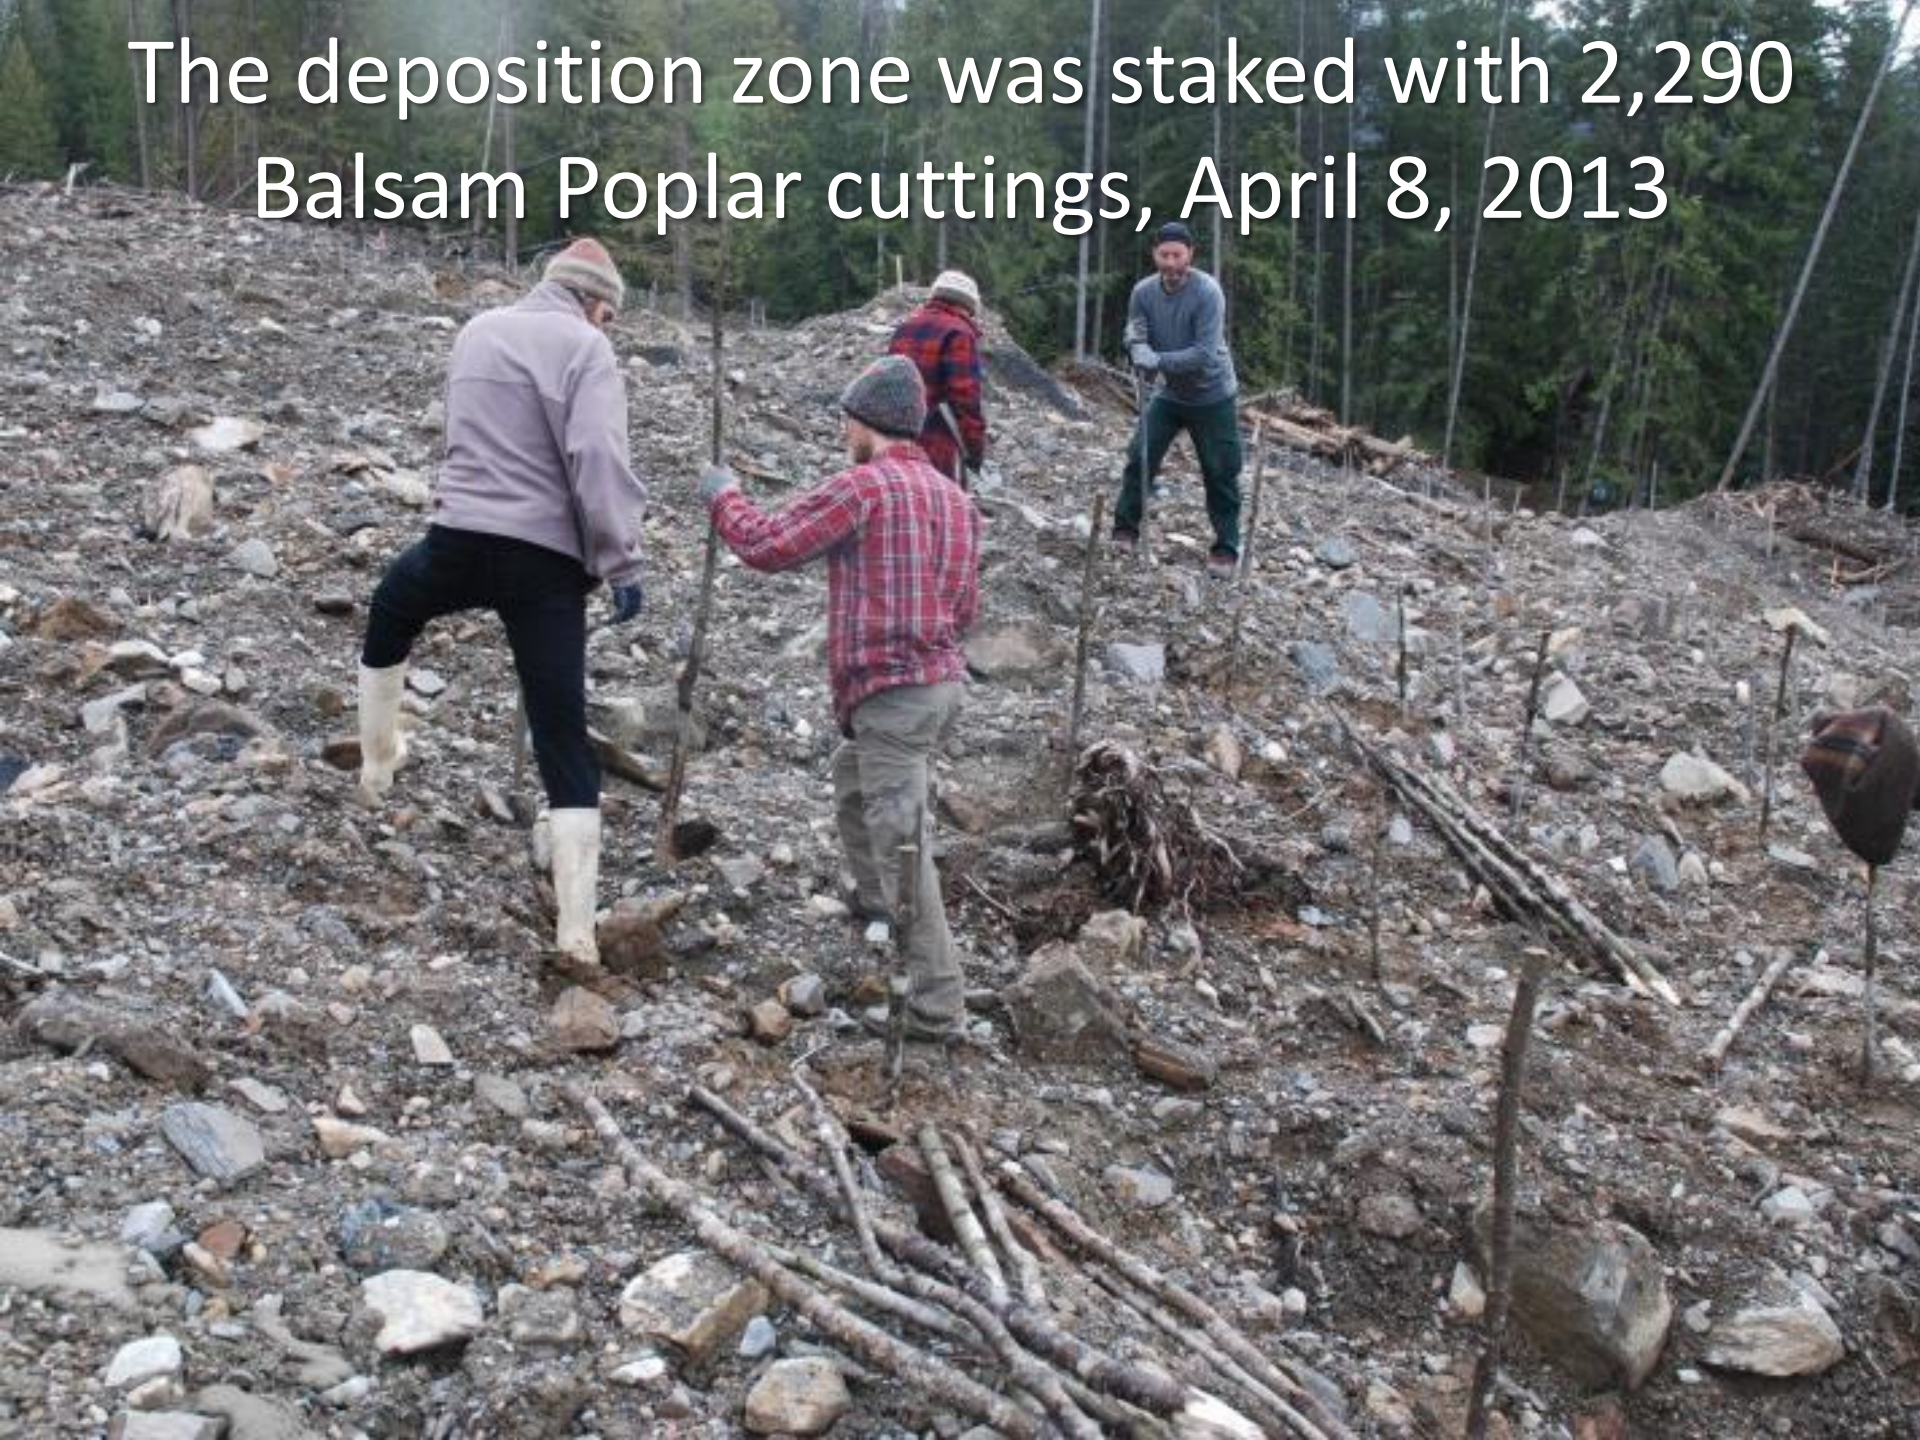
10 monitoring plots, each 1/100<sup>th</sup> ha in size, were established, April 12, 2013
